Comprehensive Sewer Rehabilitation Design and Field Investigation in Jefferson County Summary and Case Studies

DANIEL WHITE AND TINA SHEIKHZEINODDIN

Jefferson County Sewer Service Area

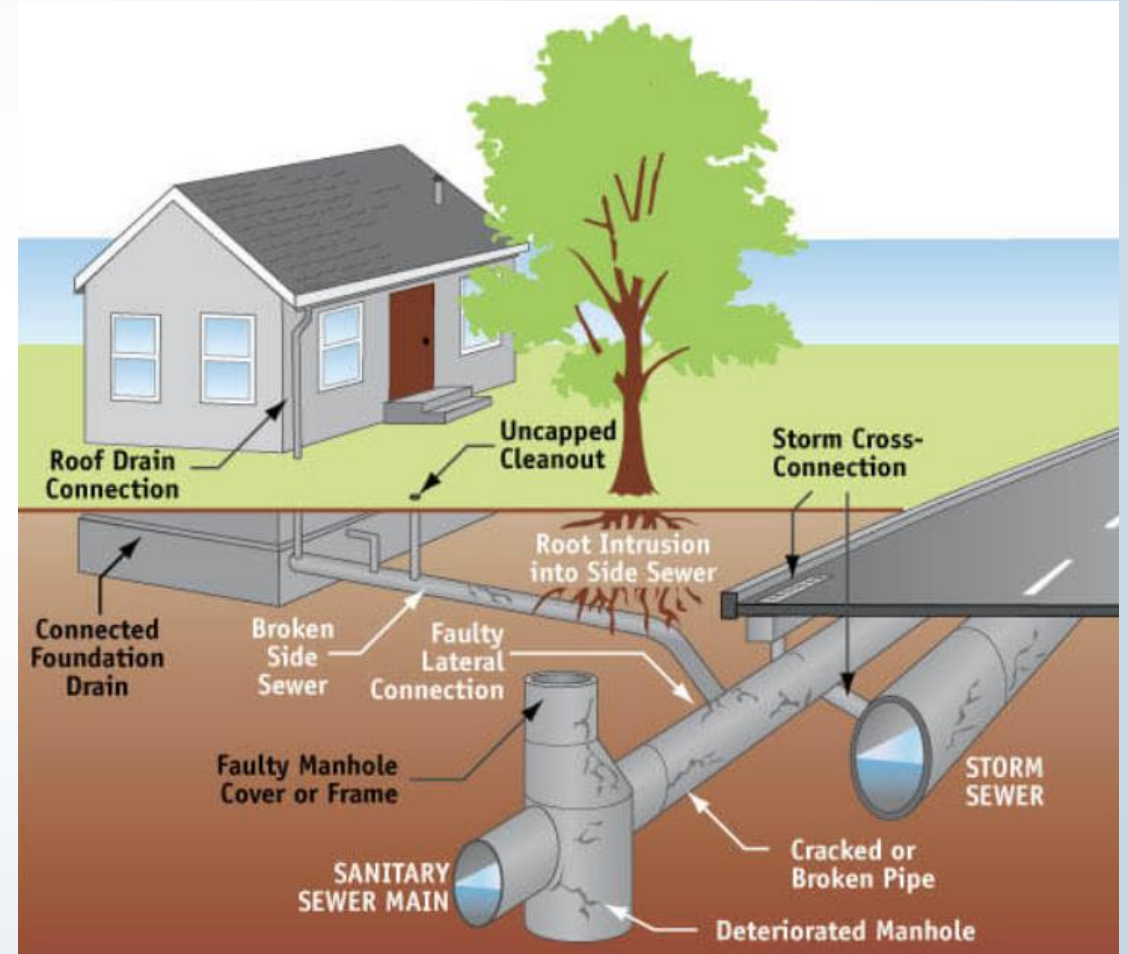
Comprehensive Rehabilitation - Mainline

Cured-in-Place Pipe (CIPP) Lining

End seals at manholes

All structural defects requiring excavation are repaired prior to lining (typically under a separate contract)

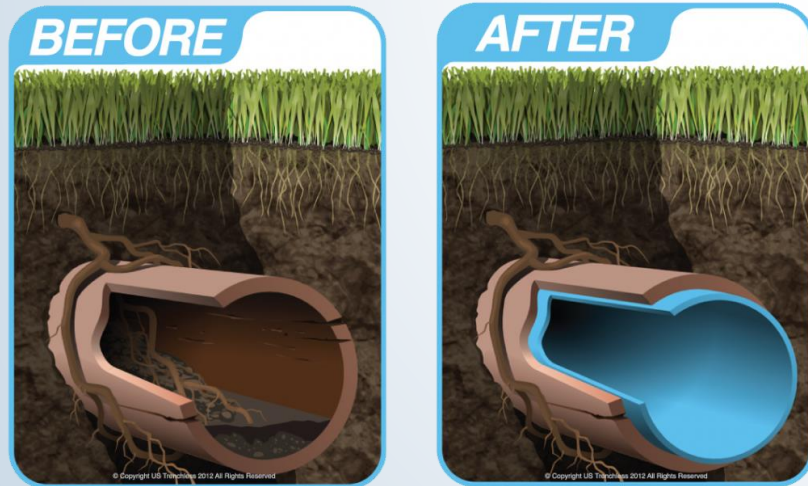
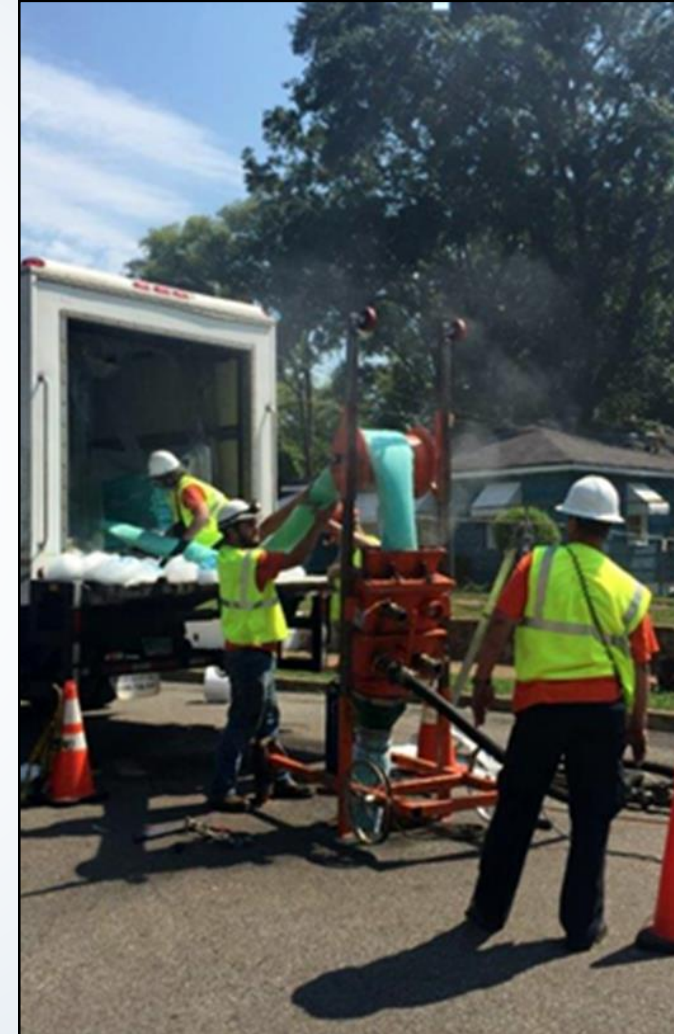
Comprehensive Rehabilitation- Lateral Launching

- Identifies active and inactive service laterals
- Sometimes it's a tough call whether a house is abandoned or not – does it look like it could be made livable again? Roof?
- Identifies significant defects at the lateral that will require excavation for repairs
- Especially beneficial in older neighborhoods with a large number of inactive services

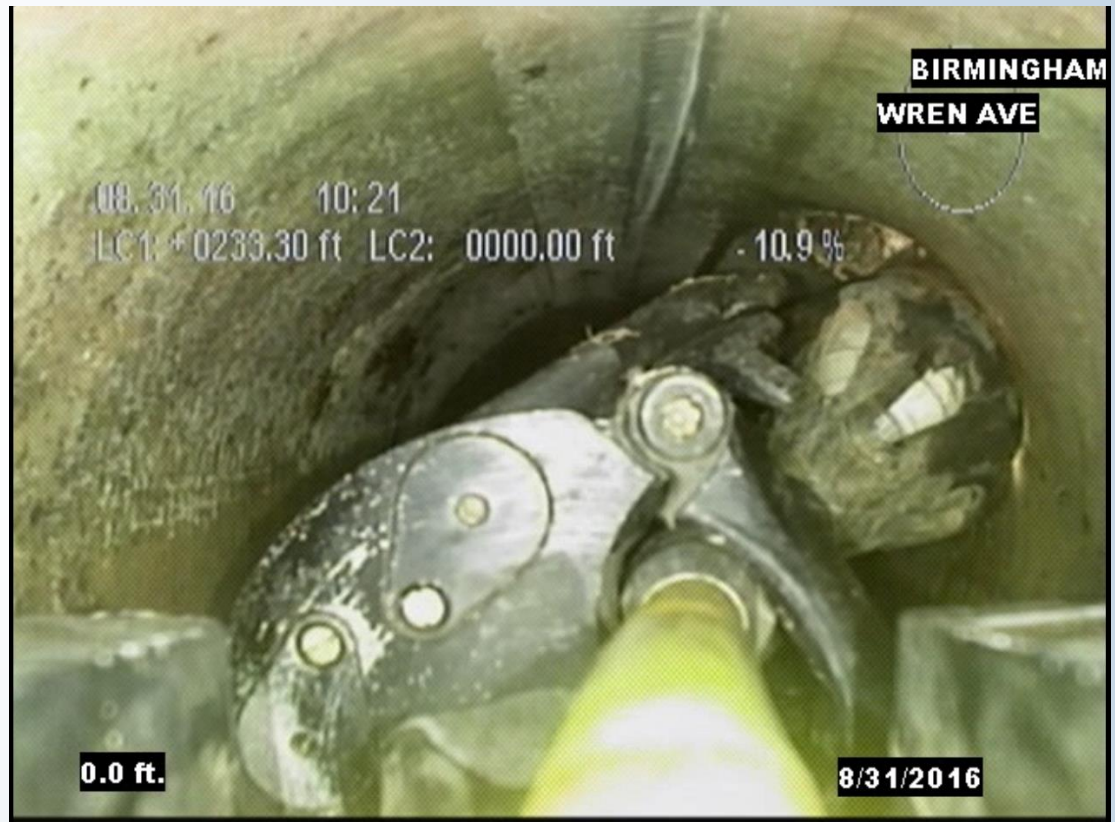
Comprehensive Rehabilitation – Service Laterals Work

Generally line 15' up the lateral

Full-Circle lateral lining

Only active laterals are reinstated following mainline CIPP

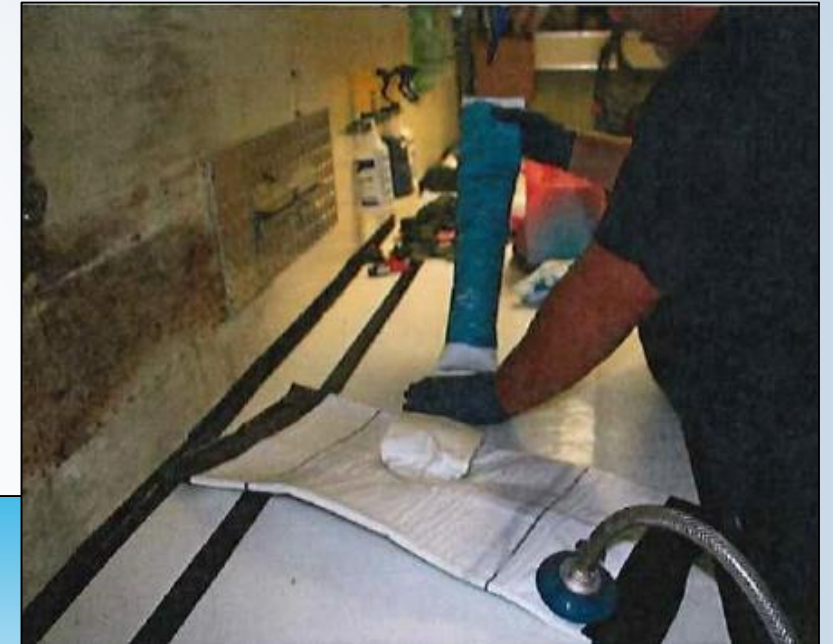
Comprehensive Rehabilitation - Manhole

Internal Liner System

Chimney and Frame/Cover
Seals

Chemical Grouting

Manhole Inserts (i.e.
Rainstopper) to prevent
inflow where applicable

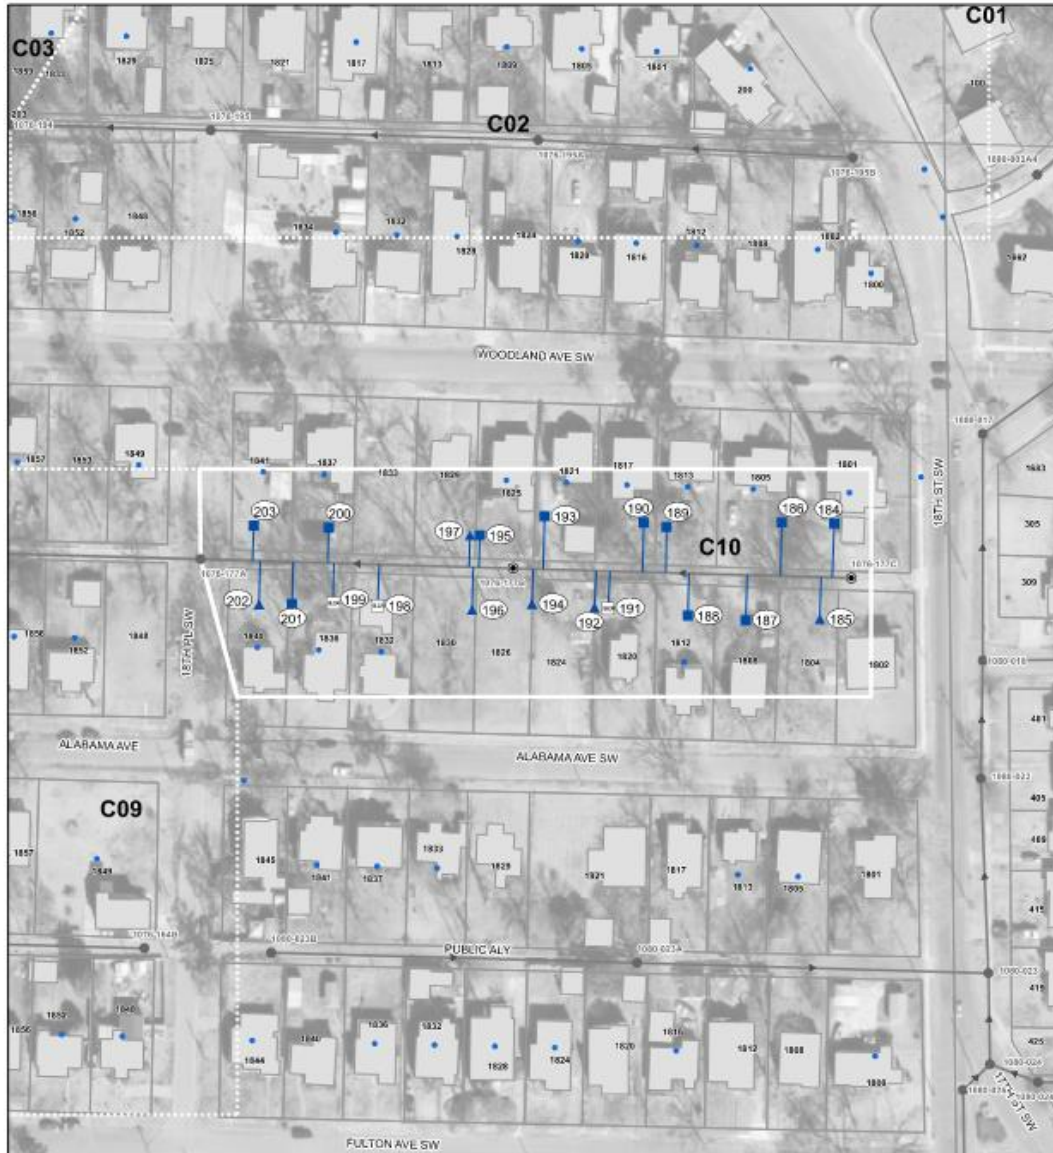
DATE	APRIL 2022
PROJECT NO.	E2114
SHEET NO.	18 OF 46
DRAWING NUMBER	C10

MAINLINE REHABILITATION SCHEDULE

SERVICE REHABILITATION/REPLACEMENT SCHEDULE

MANHOLE REHABILITATION SCHEDULE

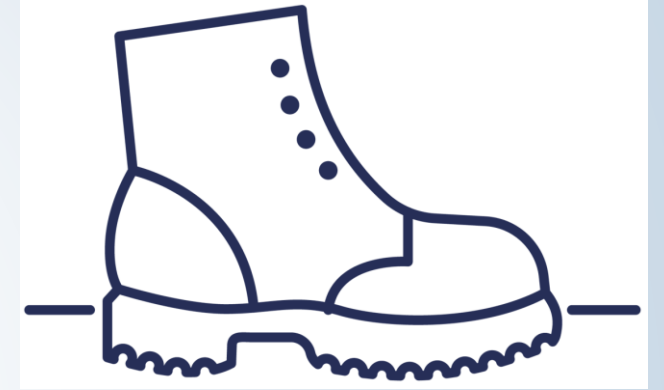
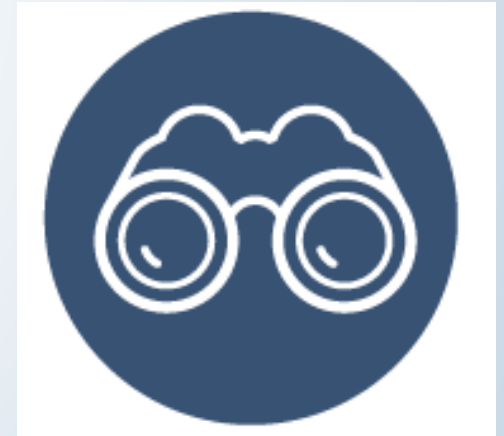
Allows you to physically see the severity of structural defects

- Are they clustered?
- Are the defects line-able or will it require repairs be made first?

In some cases, this detailed review has shown that the defects are isolated and full comprehensive sewer rehabilitation is not required to reduce I/I, or the review has revealed a problem that requires a different solution

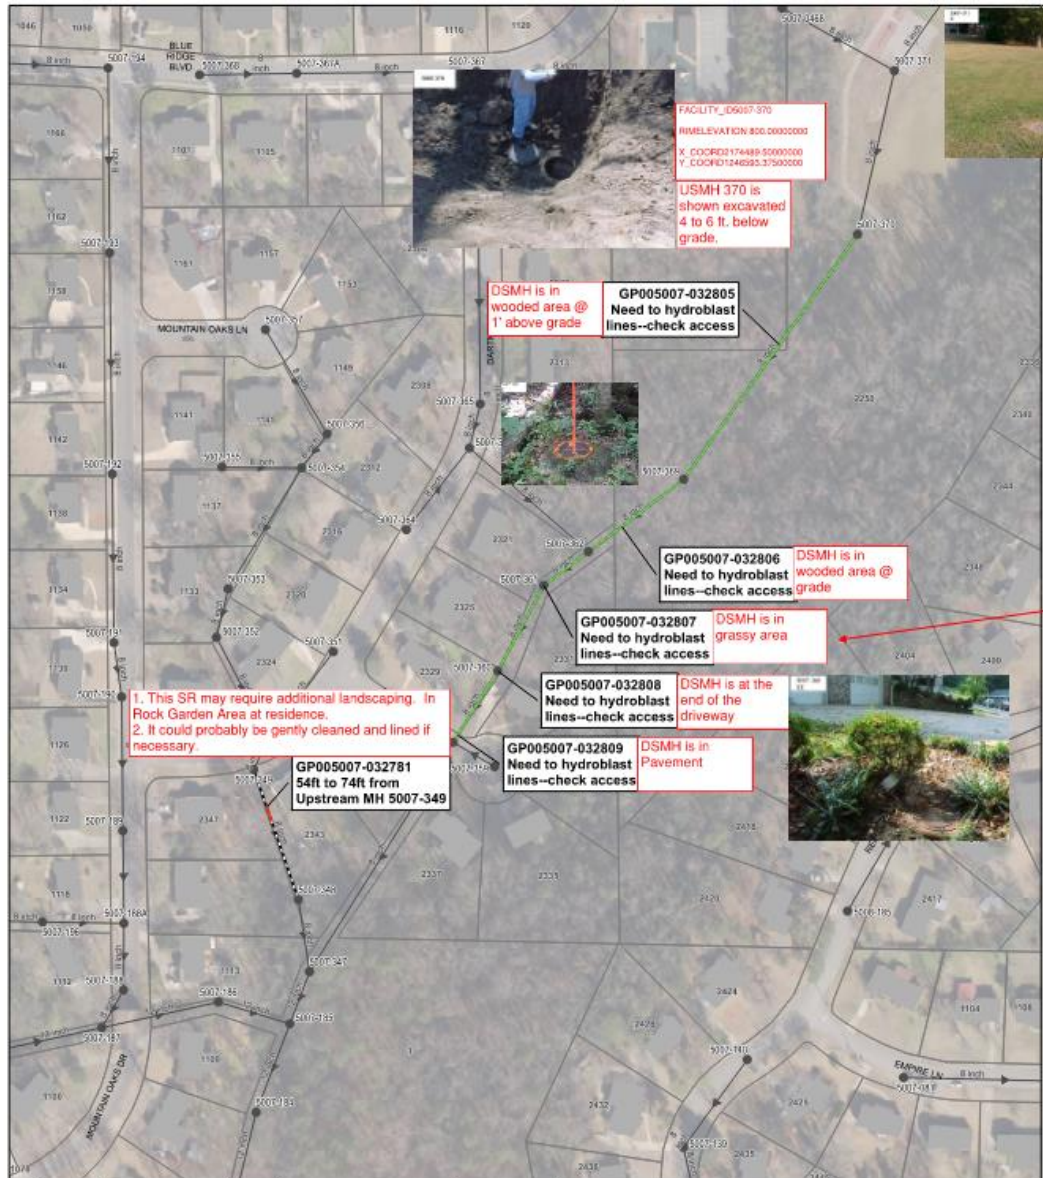
DATE: MAY 2021
HAS JOB NO: 31262-002
TASK: _____
PROJECT NUMBER: _____
DRAWING NUMBER: C06

PIPE REPAIR/REPLACE SCHEDULE

ASSET ID	REASON	GIS LENGTH	CCTV LENGTH	COMPLETE CCTV	MISSING CCTV	LINED	SAG	JOINT OFFSET	NOTES
GP005007-032781	Roots	196	167	Yes

**CIVIL
 PLAN AND REPAIR SCHEDULE
 FIELD REVIEW**

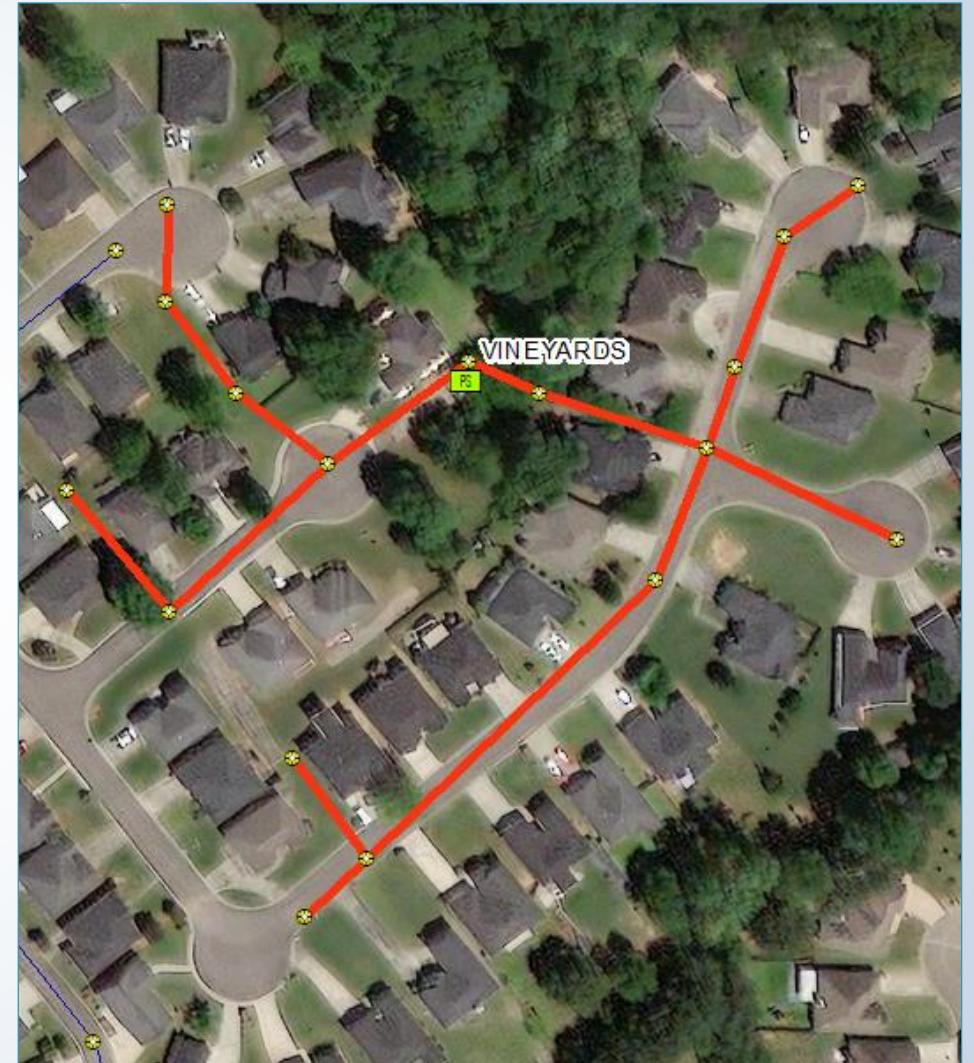
Case Study 1 - Vineyards Pump Station

Unusually high run times following rain events

CCTV review showed the sewer mainlines were all relatively new DIP/PVC and in good shape

Only one infiltration source found at the manhole immediately upstream of the wet well (but inside the PS fencing)

Approximately \$15k of manhole rehab and grout injection versus \$250k of comprehensive rehab in the PS service area

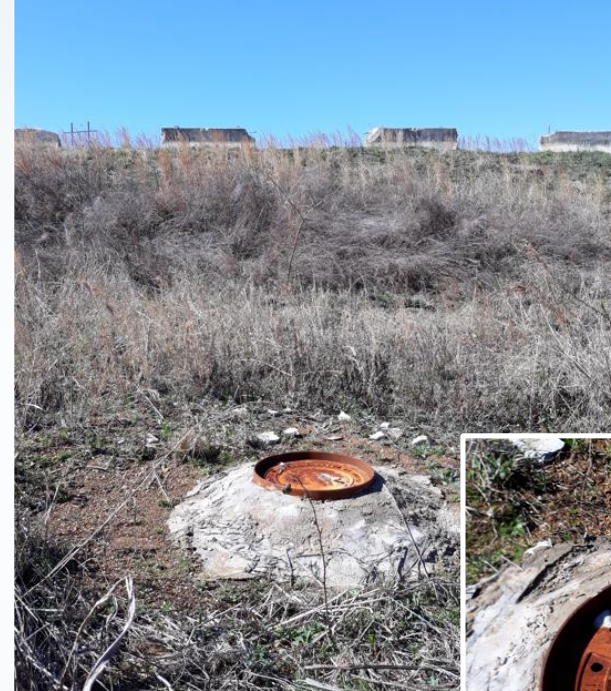
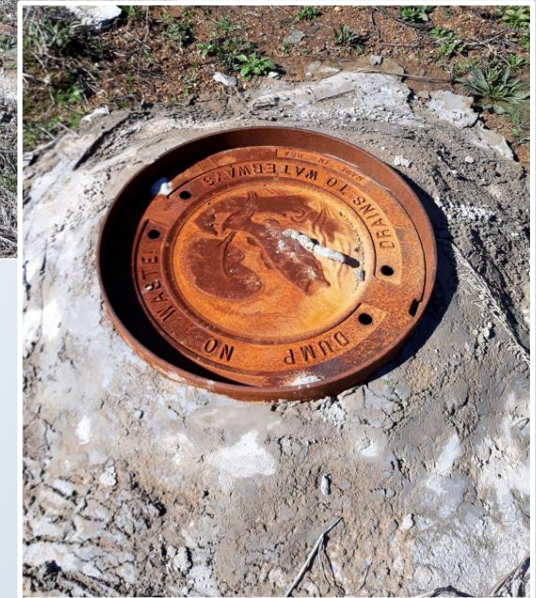
Case Study 2 - Garywood Pump Station – Red Farmer Rd

- During field review of the planned rehab project, it was found that a contractor had filled two vacant lots and redirected the stormwater runoff directly to the sanitary sewer system
- Manholes became flooded during rain events
- Contractor had also dislodged the frame and cover on one of the manholes which provided a large hole for the stormwater to enter the sanitary sewer system.

- Regraded some areas
- Raised and sealed the manholes; replaced frame and covers where needed

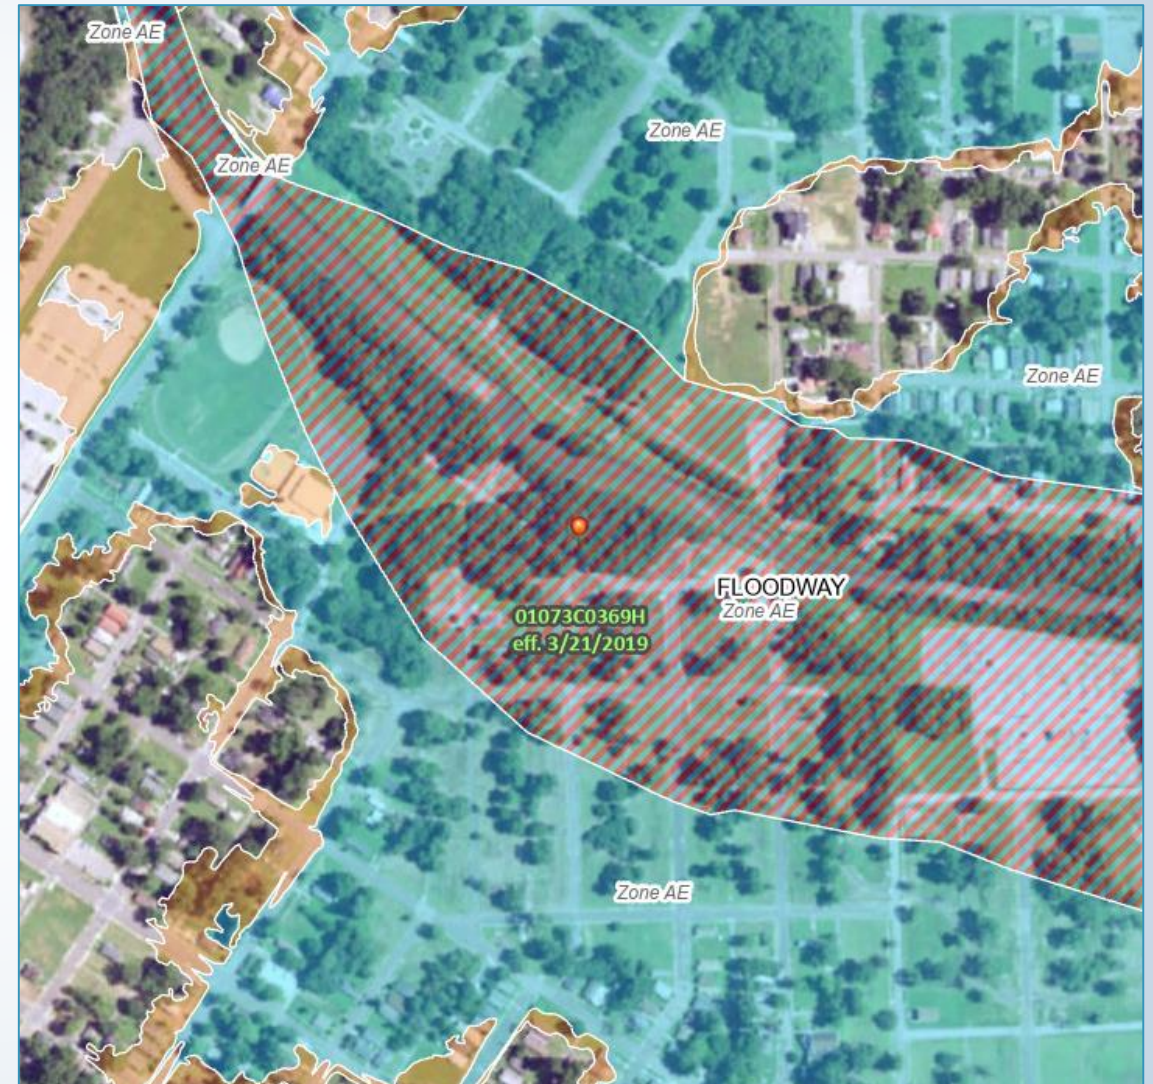
Case Study 3 - McAlpine Pump Station

High R-value determined during flow monitoring and modeling

Federal flood zone buyout area; houses previously demolished under this program

Inactive sewers remained in system

Plugged and disconnected “non-essential” sewers from the rest of the system

Reduced wet weather flows to some extent, but comprehensive sewer rehabilitation is still needed in this area

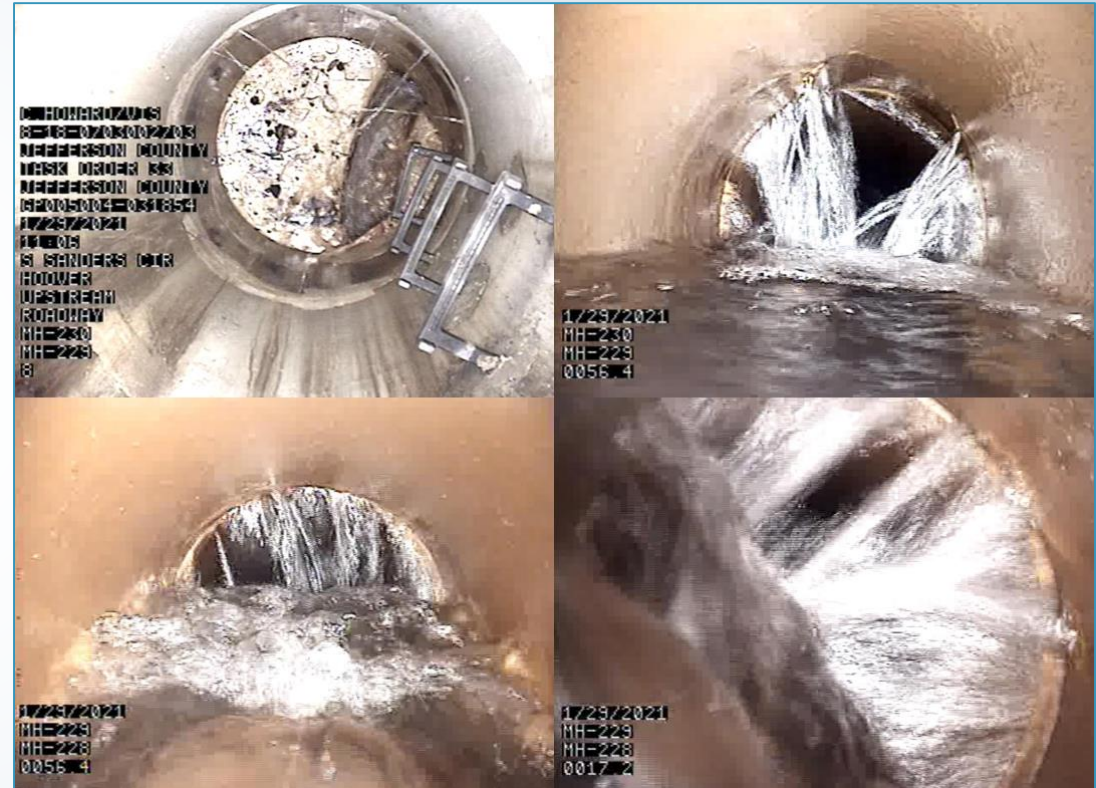
Case Study 4 - Fargo Drive/Foothills Drive Water Break

This area was identified for comprehensive rehabilitation due to high R values and recent SSOs

CCTV review revealed two lines with significant I/I (seemed pressurized)

Suspected water main break since the sewer was in a residential road

Notified Birmingham Water Works and the water main break was fixed

Flow meter information showed when the fix was made and reduced dry weather flow

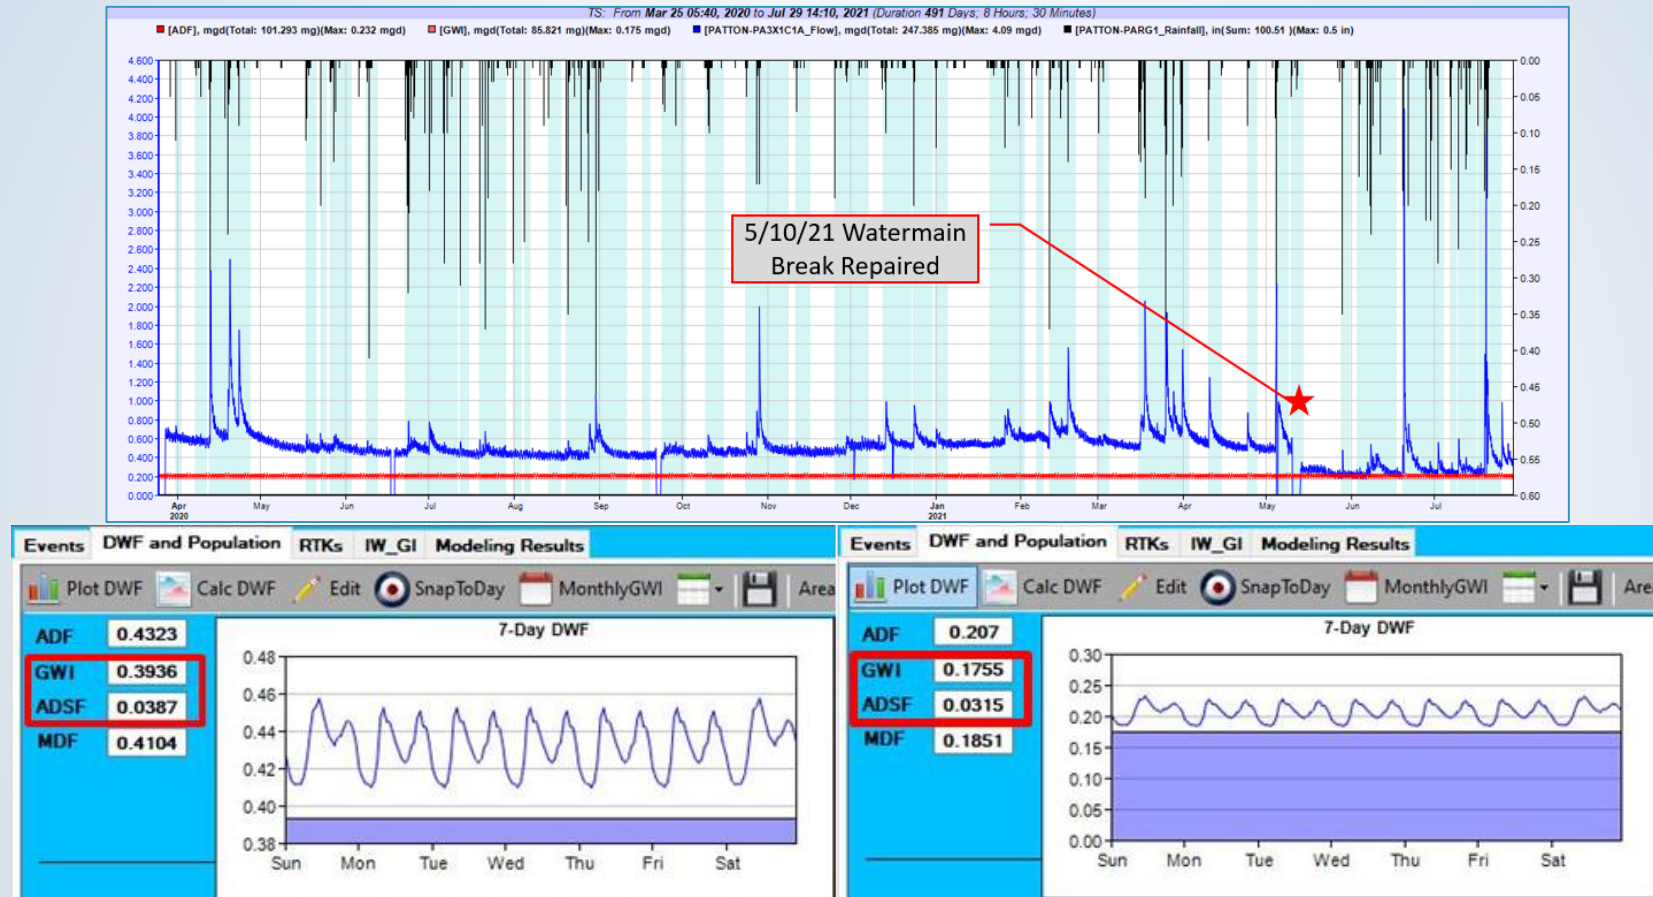
Case Study 4 - Fargo Drive/Foothills Drive Water Break

55% GWI reduction with no capital expenditures!
