GulfQuest

National Maritime Museum of the Gulf of Mexico

Structural Challenges for Design

Presented by:
Robert A. Harvey, P.E.

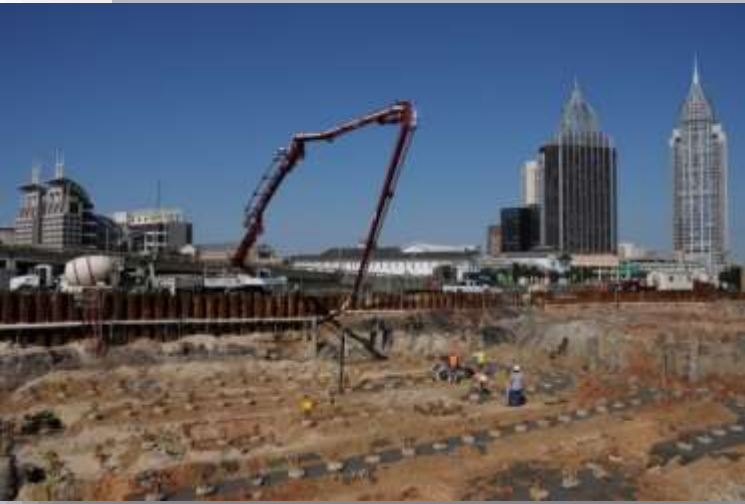
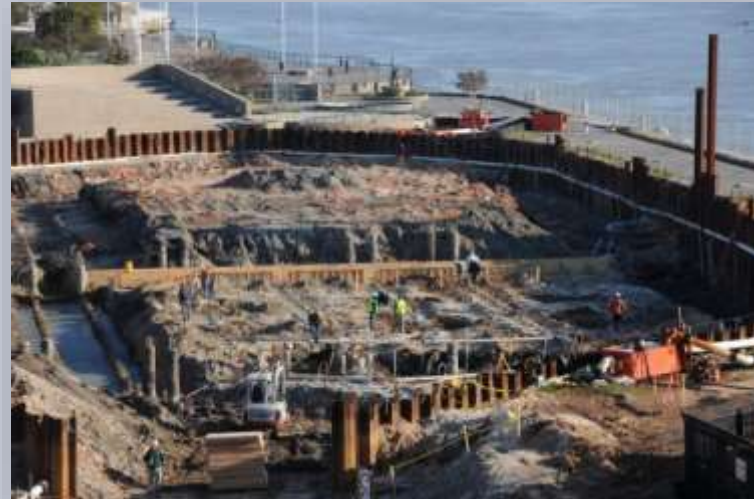
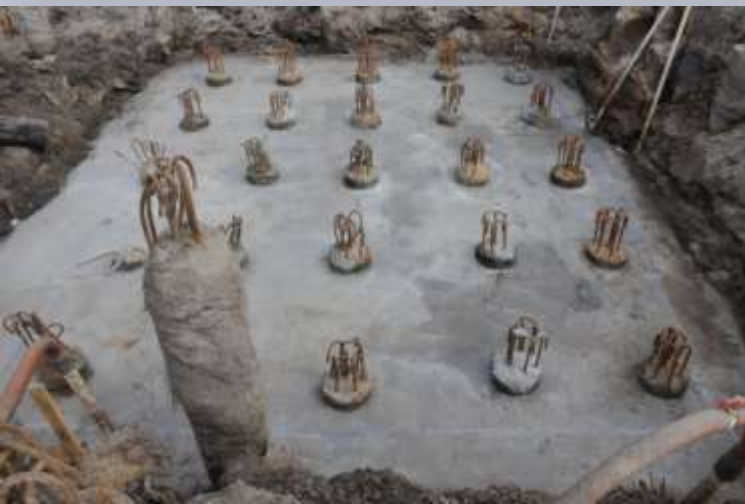
- Shoring
- Well points and dewatering system
- Drill displacement piles
- Basement floor elevation at +6", outside grade is +8.0 ft.
- Basement floor is water proofed to prevent water intrusion

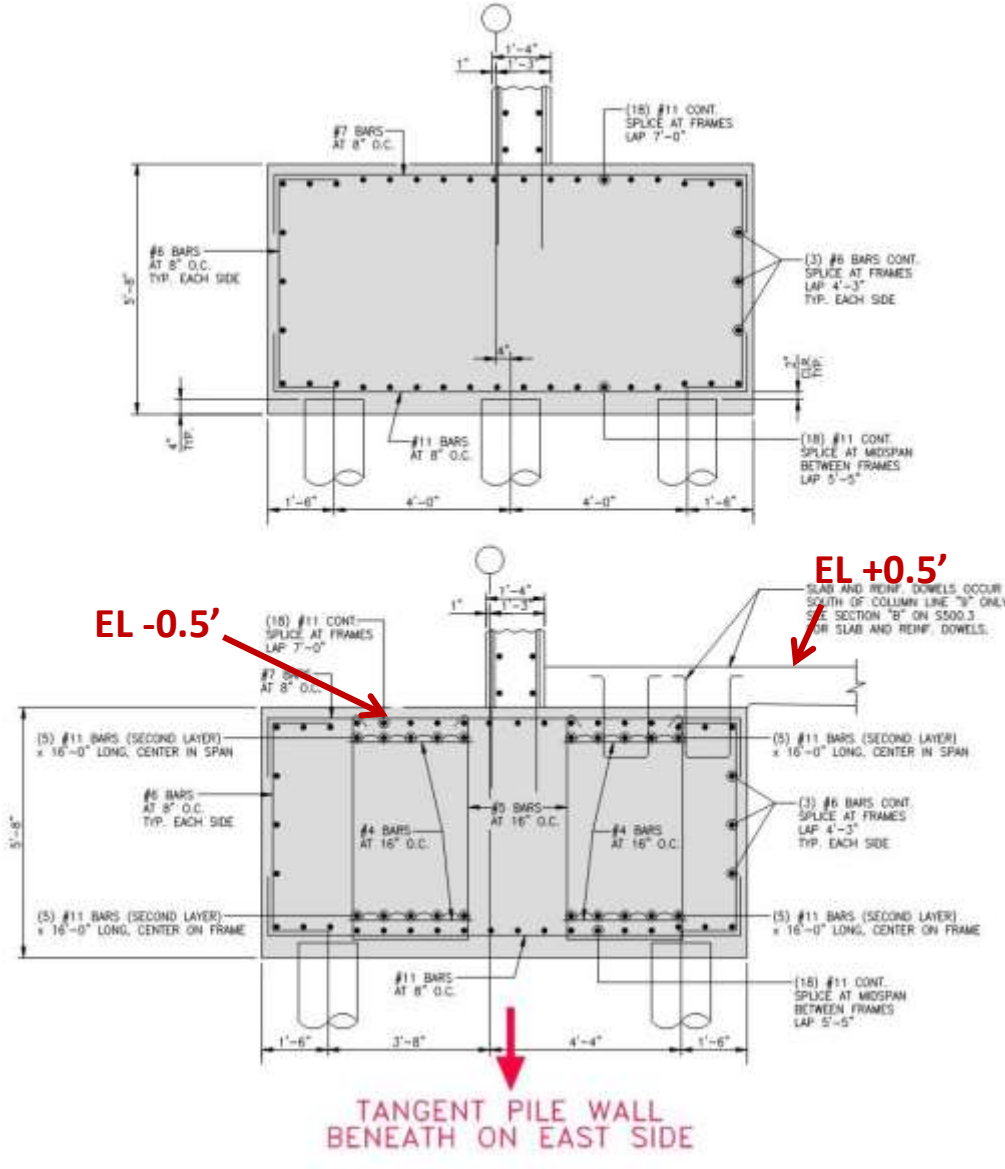
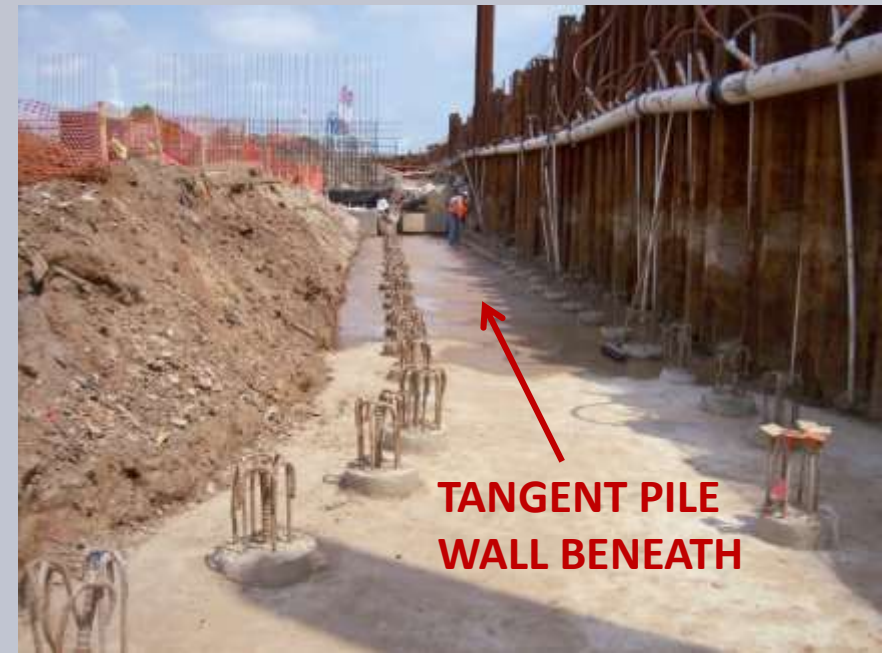
- Interference of existing timber, Tangent Pile Wall beneath on east side.
- Pile cap reinforcement was increased from 60 to 75 KSI

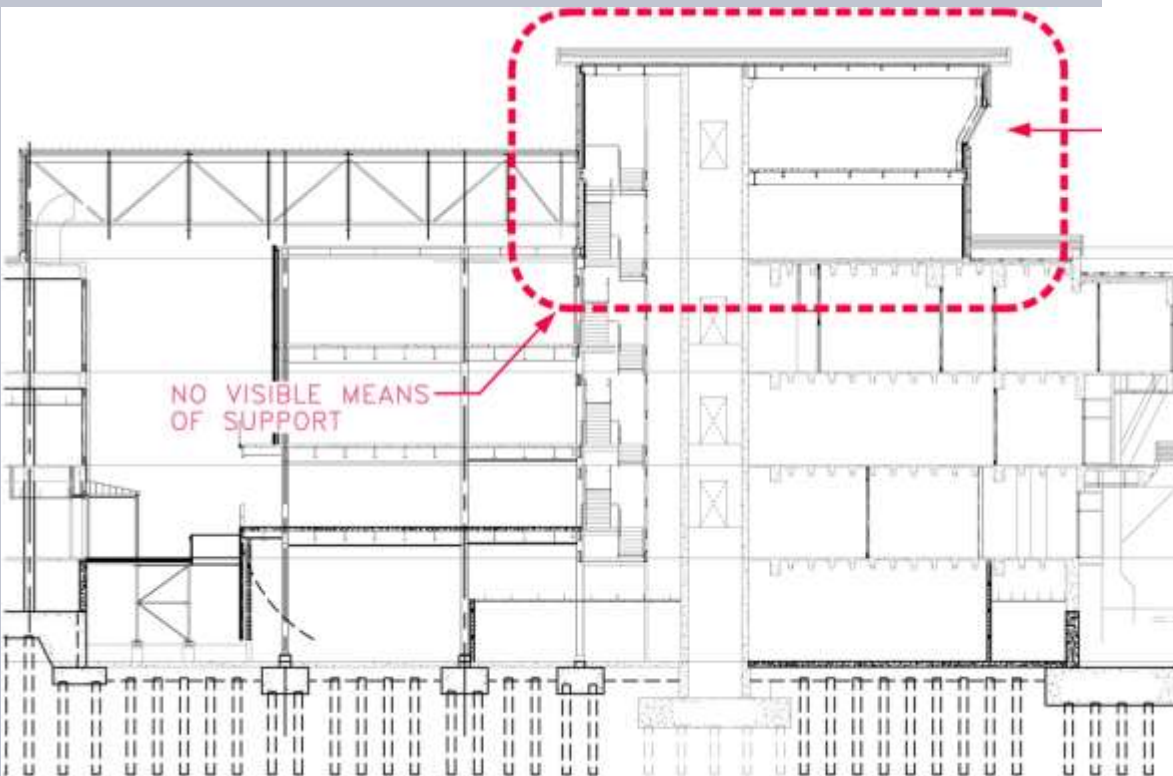
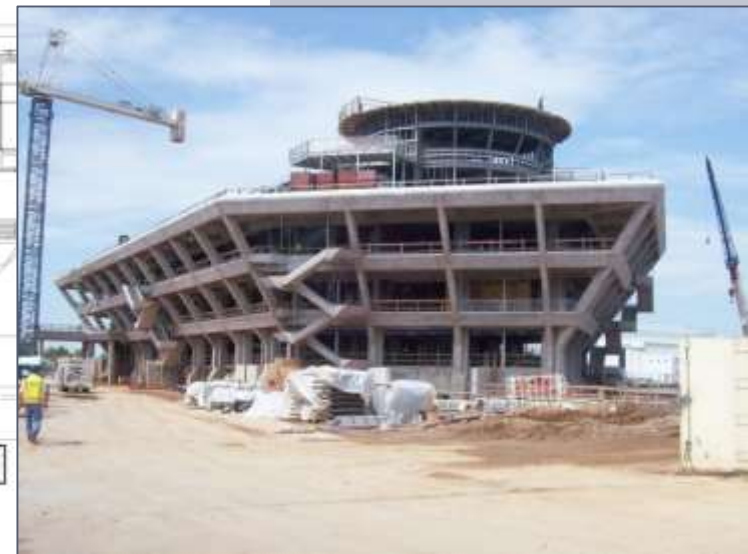
- The circular bridge was originally designed out of concrete – problems with shoring on three columns at Northside; no visible means of support.

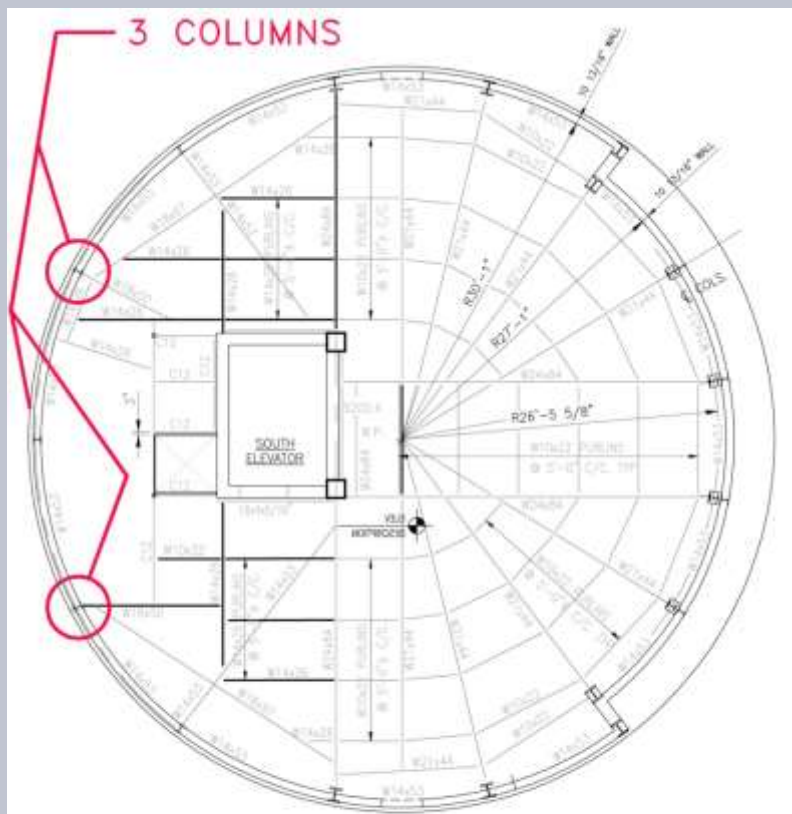
**BRIDGE FLOOR FRAMING
EL. 74'-7"**

- Design changed from concrete to steel
- Installation challenges
- Steel fabricator (Steel, Inc.) and steel erector (Atlanta Steel Erectors)

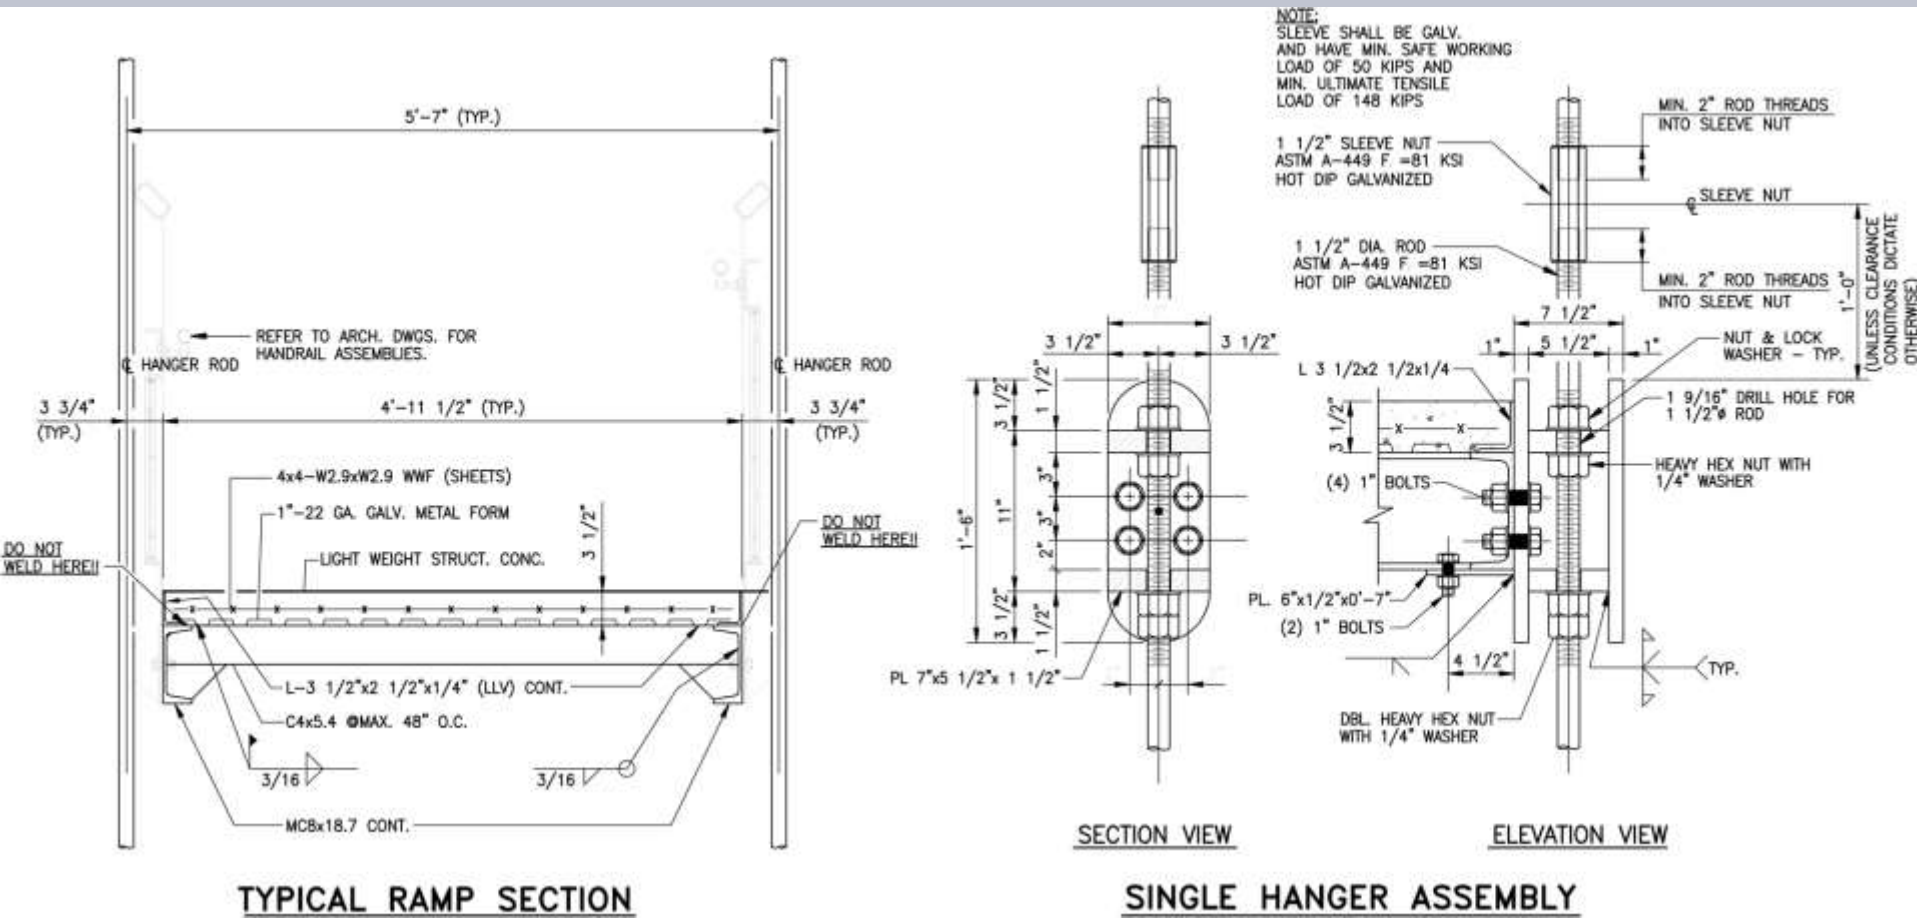
- Design – 5-foot wide walkway
- 3½-inch concrete deck on metal deck
- 8-inch channel framing (MC 8X18.7)
- Hanger assembly
- 1½-inch dia. rods, ASTM A-449
- 12-feet on center

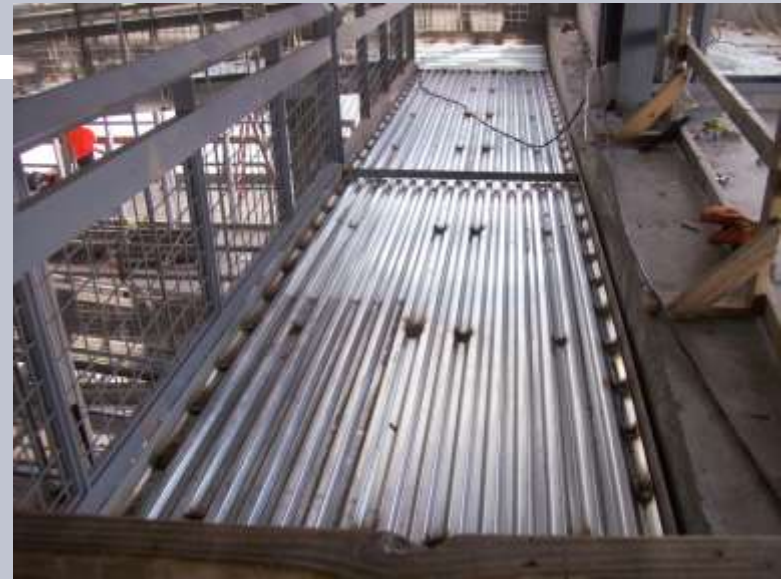
METAL DECK

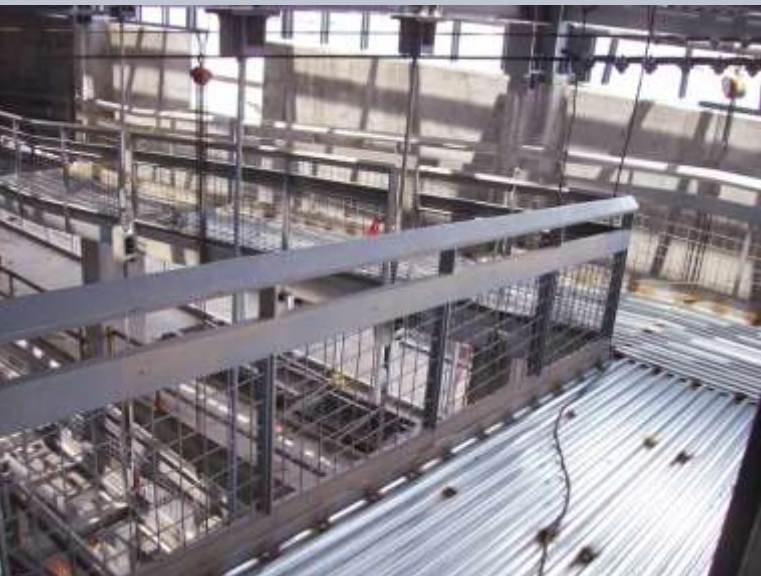
**METAL DECK AND
GUARD RAIL**

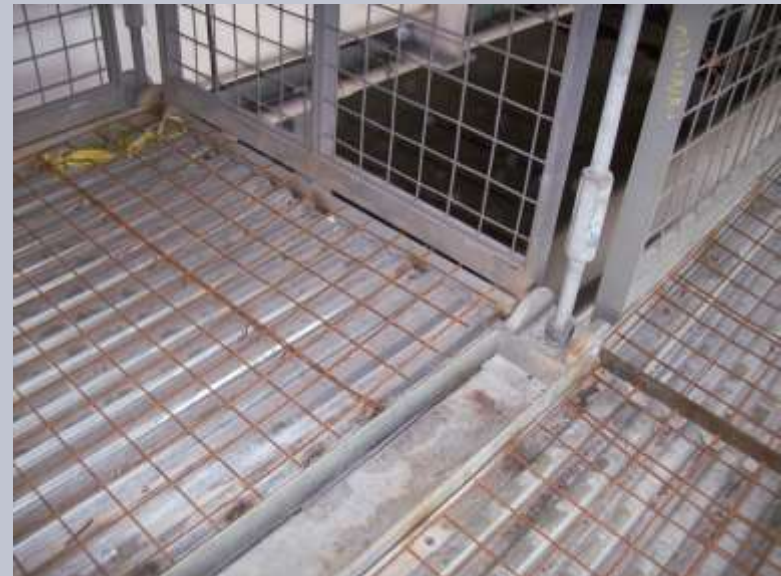
METAL DECK AND GUARD RAIL

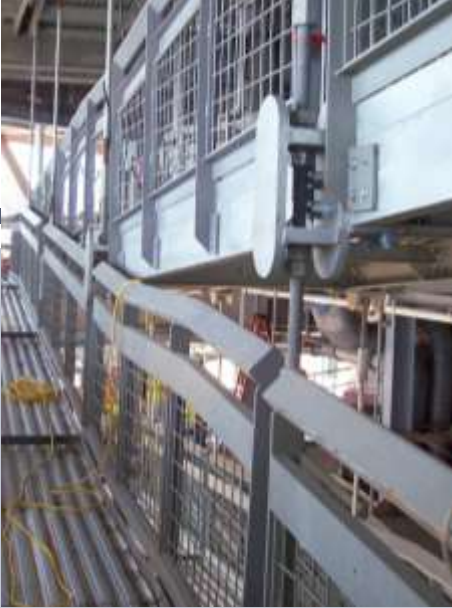
HANGAR ASSEMBLY

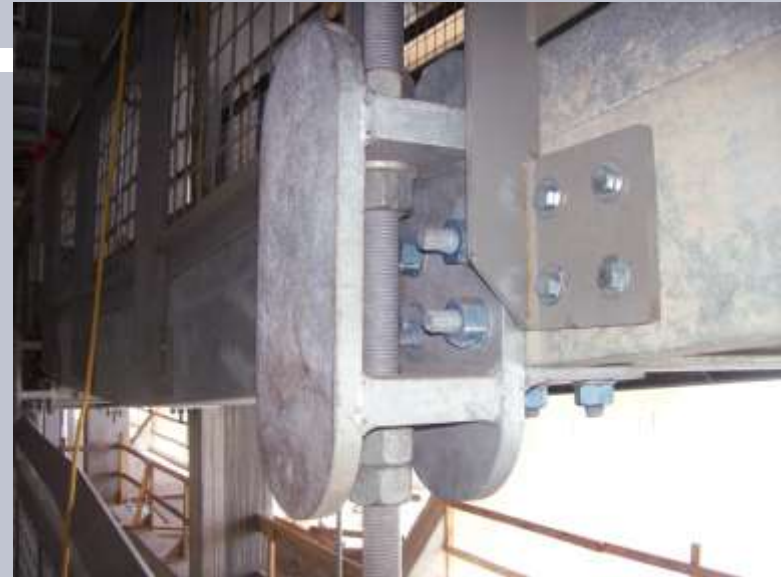
HANGER ASSEMBLY

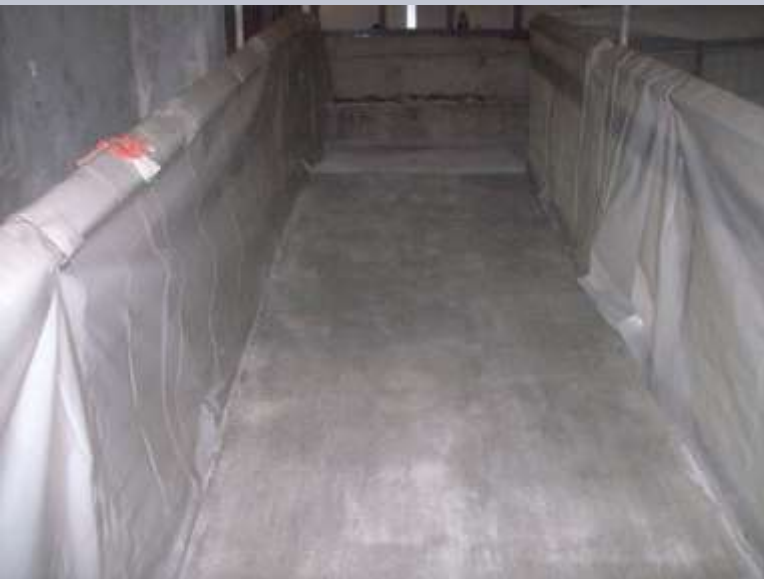
RAMP AFTER CONCRETE PLACEMENT

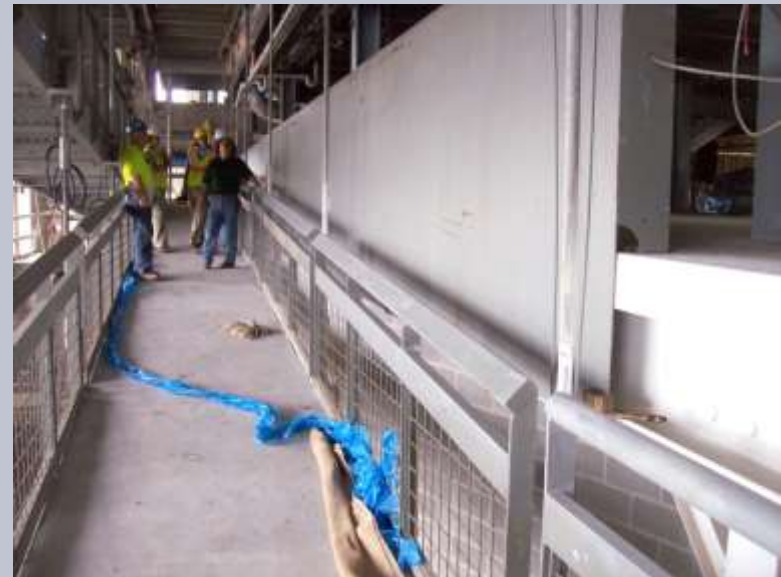
RAMP AFTER CONCRETE PLACEMENT

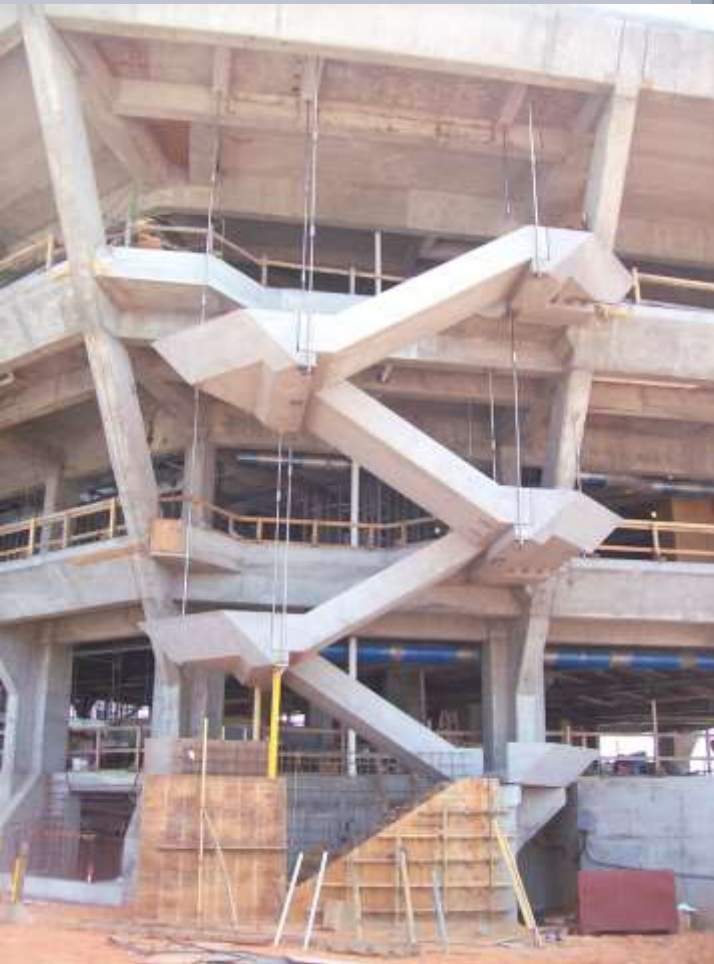
STAIR ELEVATION

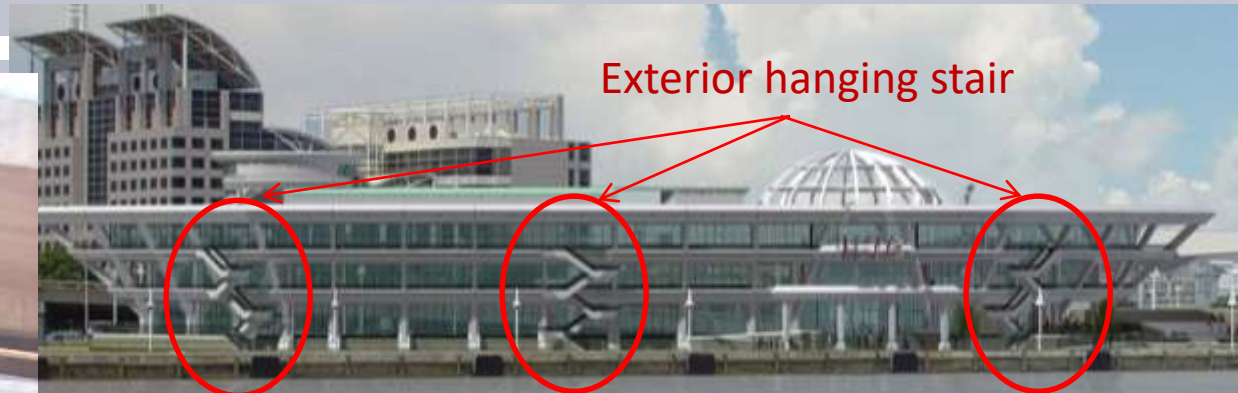
EAST ELEVATION

- Six (6) exterior hanging stairs
- Resemble hanging life boats
- Precast concrete stairs hung by SS rods

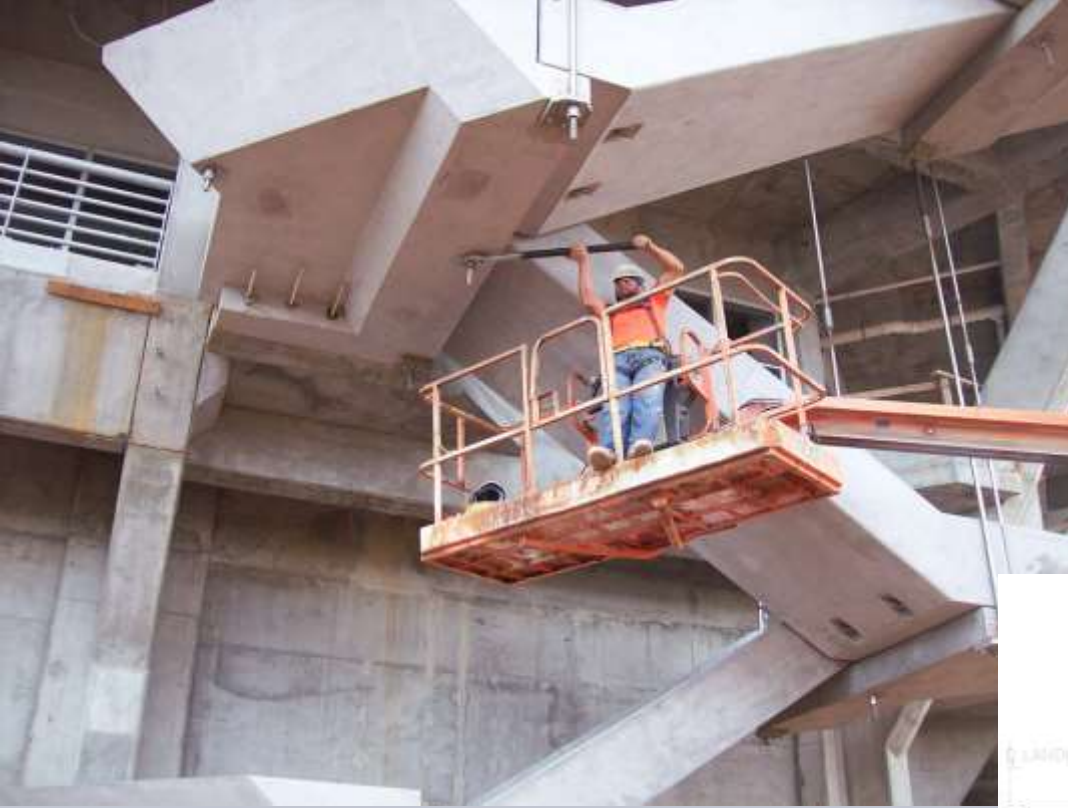
- 1 ½-inch diameter rods
- AISI 316 (SS) Strain Hardened
- F_y (min) = 50 KSI
- F_u (min) = 90 KSI
- Stair connected to floor

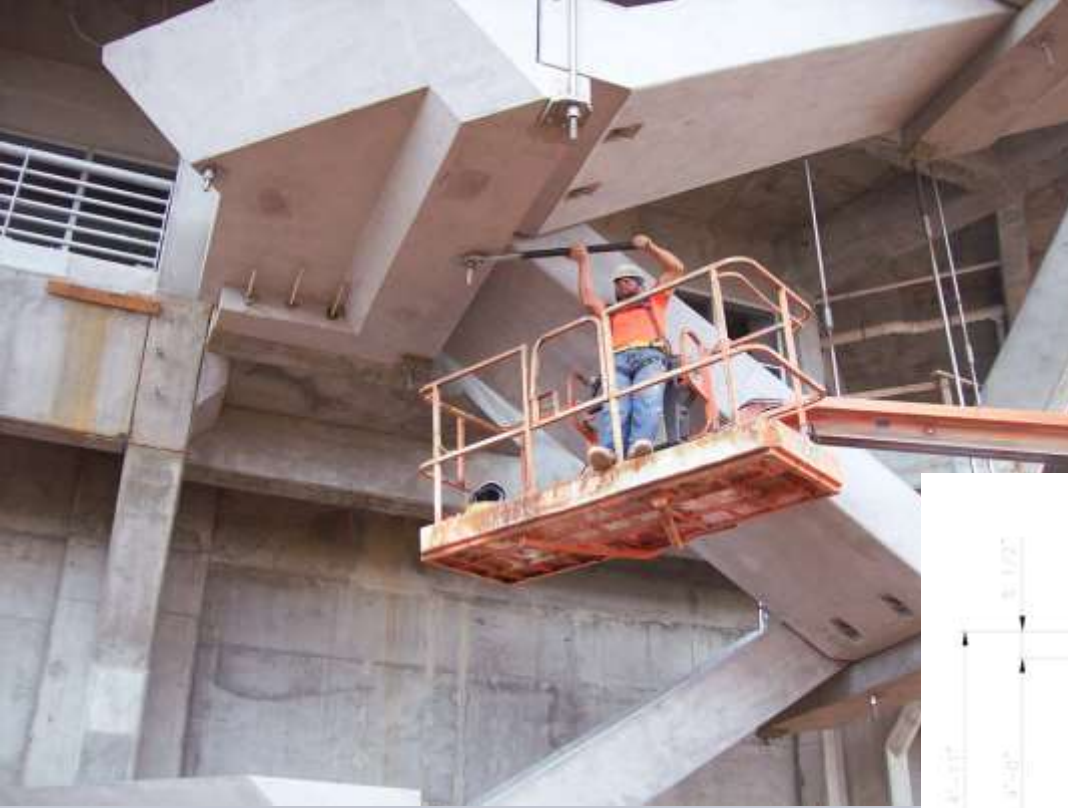
- 1 ½-inch diameter rods
- AISI 316 (SS) Strain Hardened
- F_y (min) = 50 KSI
- F_u (min) = 90 KSI
- Stair connected to floor

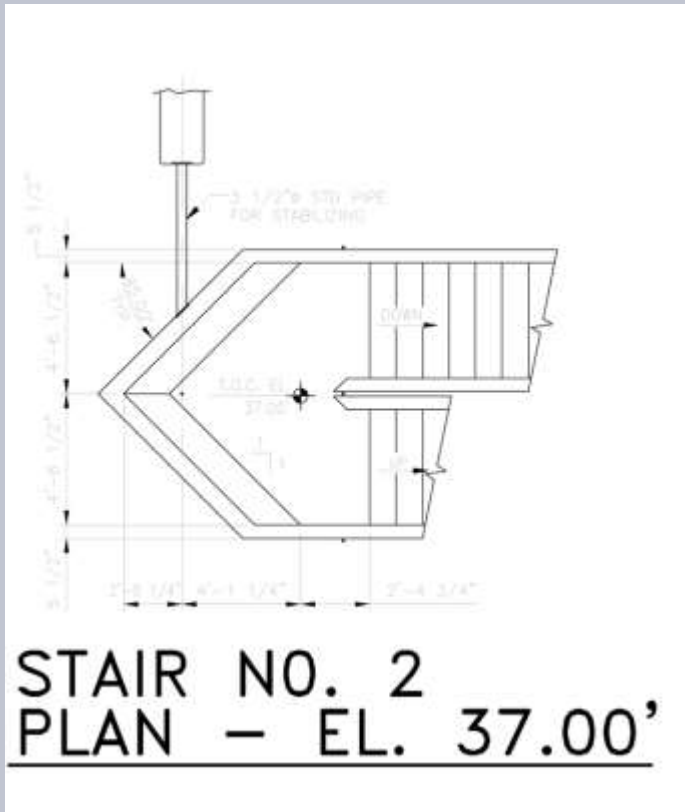
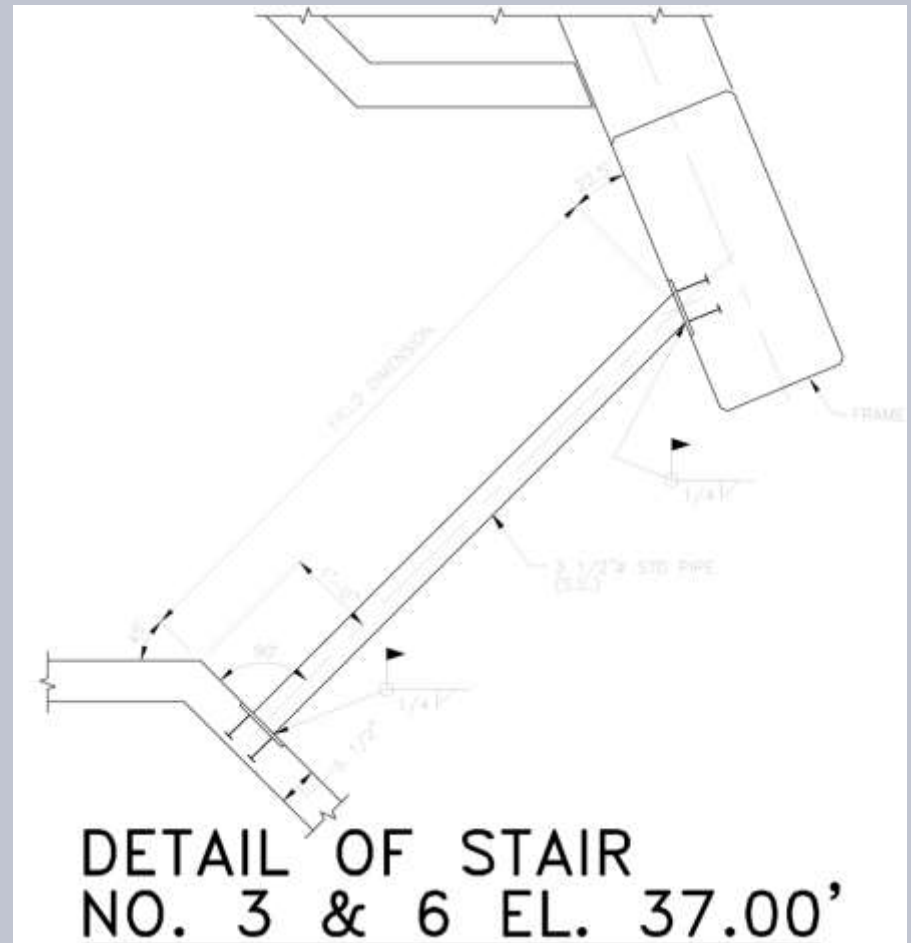
- Stability at intermediate landings, stabilizing pipe

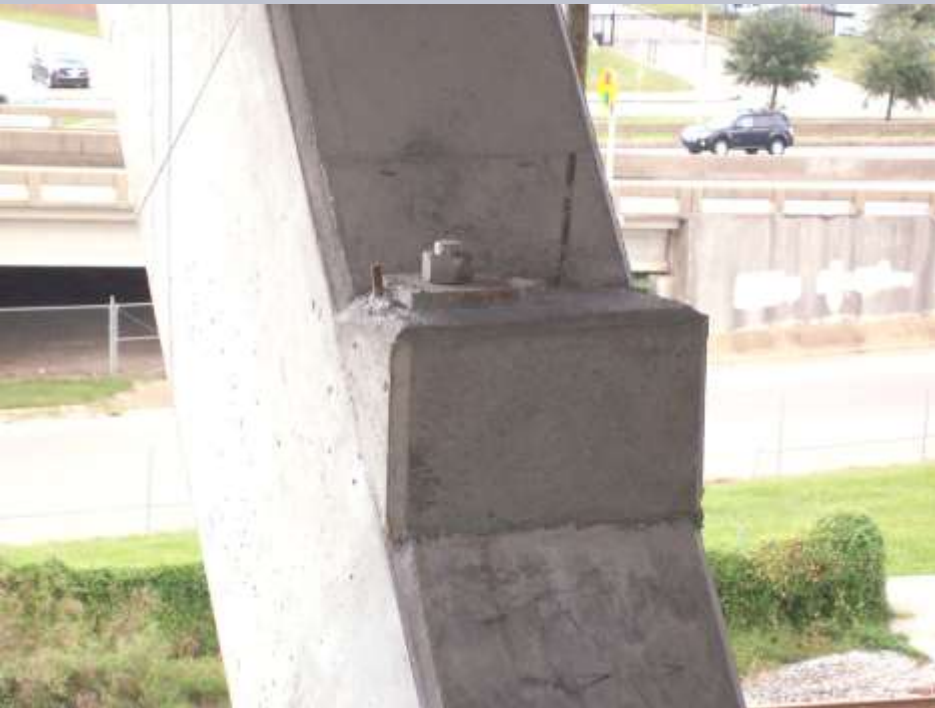
HOLES OMITTED – SOME RAKERS WERE DRILLED FOR ROD

- Installation challenges – holes in concrete beams/Rakers for SS rods

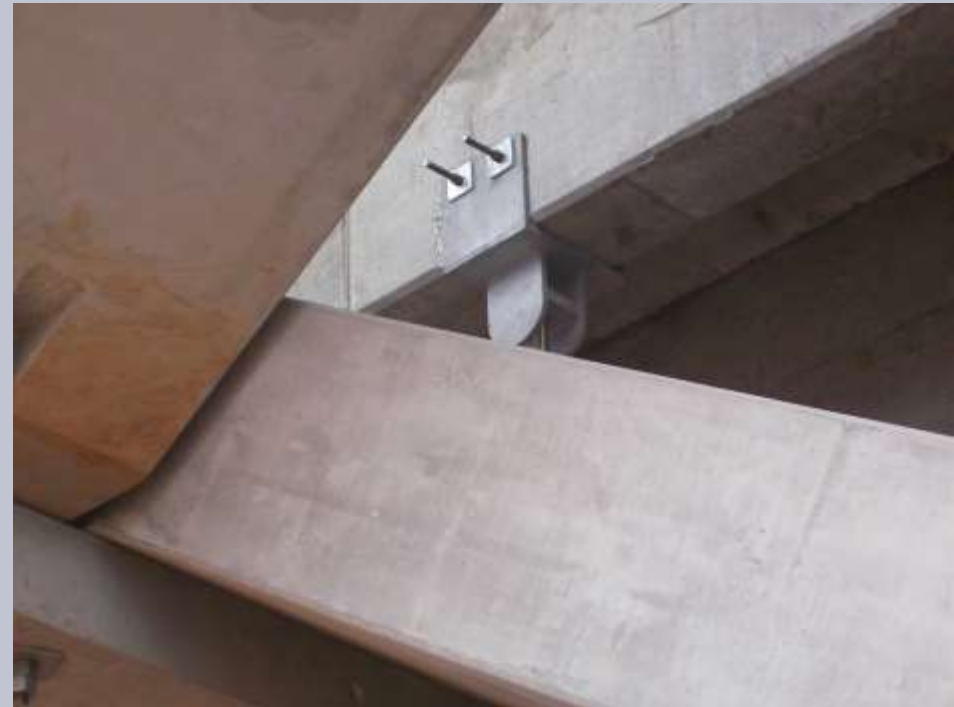
HOLE OMITTED – RETROFIT BRACKET FOR ROD
