# What we do and don't know about Alabama's dams and why it matters!

2017 ASCE Alabama Section Winter Meeting

Clay Campbell, PE  
Amec Foster Wheeler  
Environment and Infrastructure, Inc.  
Birmingham, AL

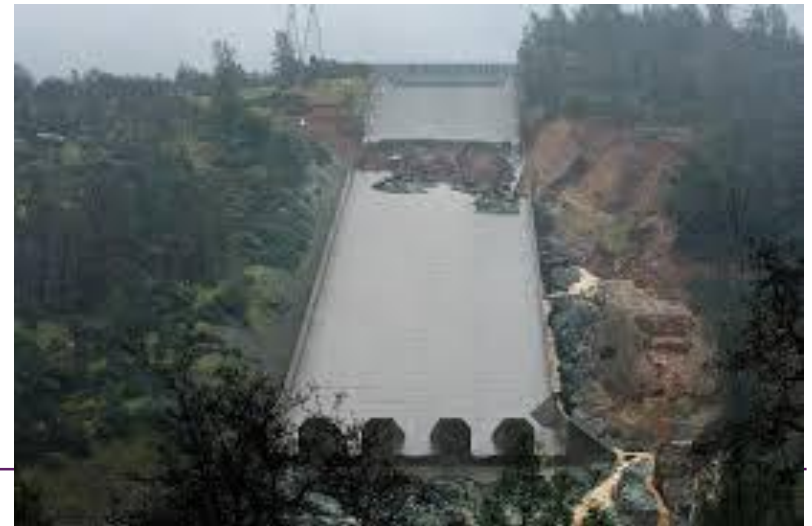
# Safety Moment - Oroville Dam

- ▶ Earthen embankment
- ▶ 770 feet tall
- ▶ Tallest dam in U.S.
- ▶ Used for:
  - ▶ Water supply
  - ▶ Hydroelectricity
  - ▶ Flood control
- ▶ Storage = 3.5 million acre-feet
- ▶ Completed in 1968

- ▶ Crater formed in main spillway
- ▶ Emergency spillway activated and eroded
- ▶ 188,000 residents evacuated

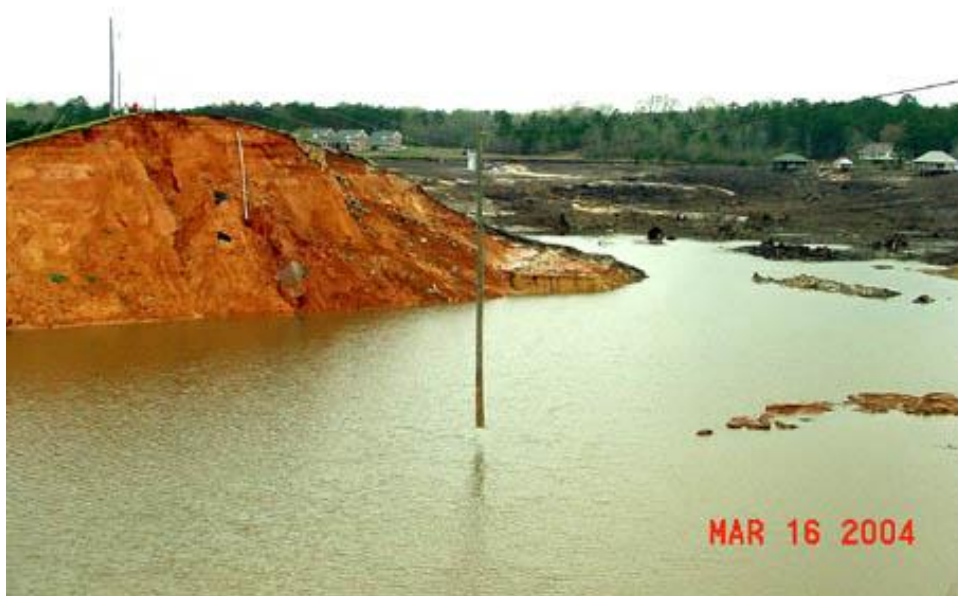
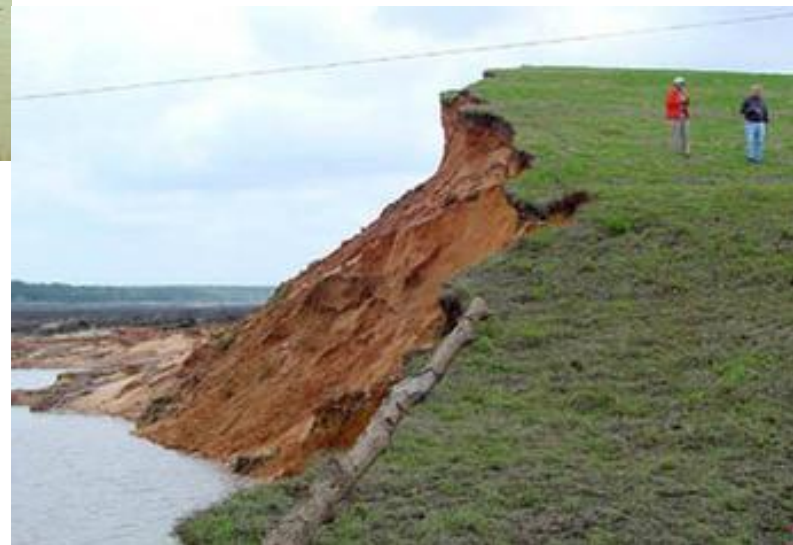
# Big Bay Lake Dam—near Purvis, MS

- ▶ Woody material stripped from stream valley for 2,300 feet immediately below the dam.
- ▶ 104 structures damaged or destroyed, no lives lost

- ▶ Piping Failure 12 years after construction
  - ▶ Growth in pre-existing seep
  - ▶ Full formation of the breach occurred in 55 minutes

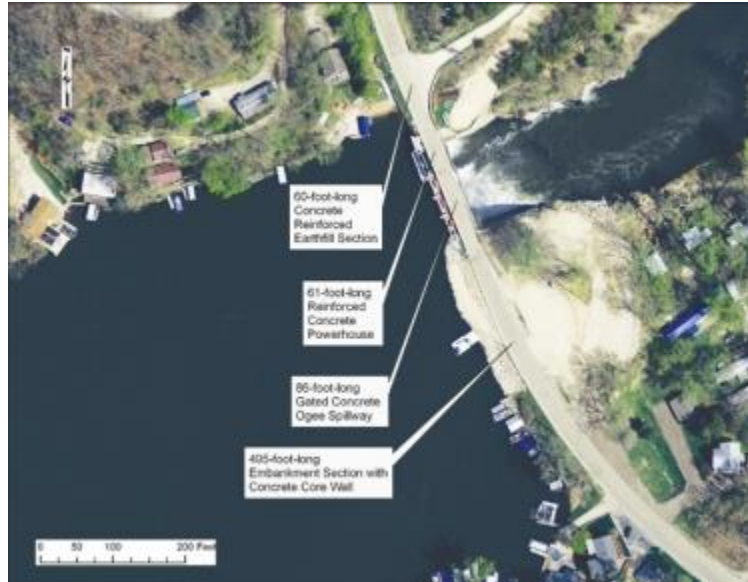
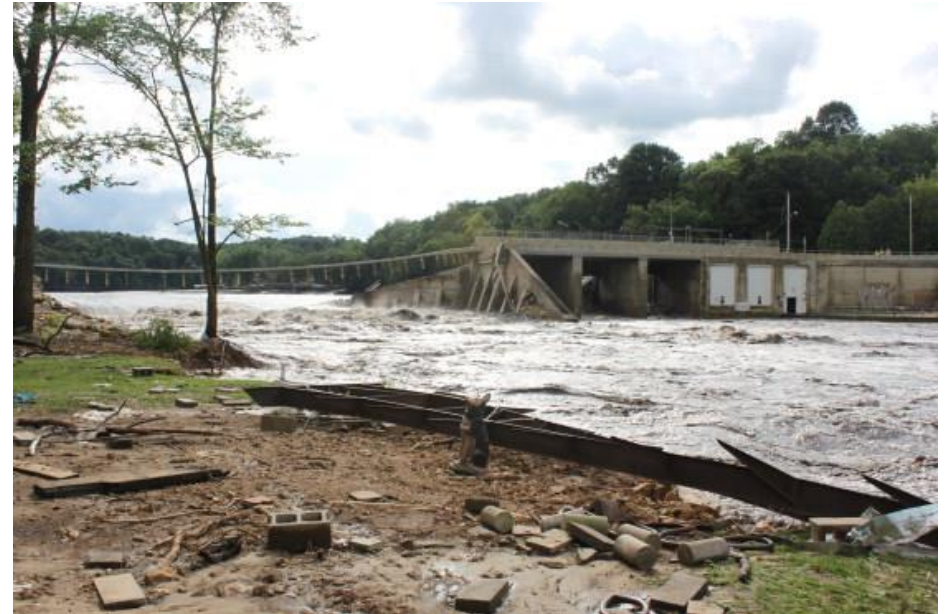
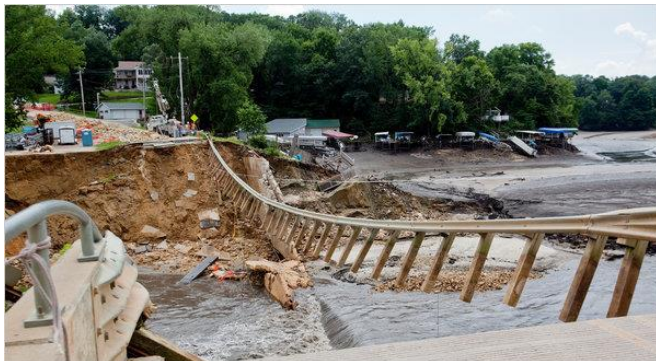
# Lake Delhi Dam--Iowa

► **Overtopping Failure**

- 10 inches of rain in 12 hrs.
- “Internal erosion in the embankment coupled with overtopping”
- 8,000 people evacuated

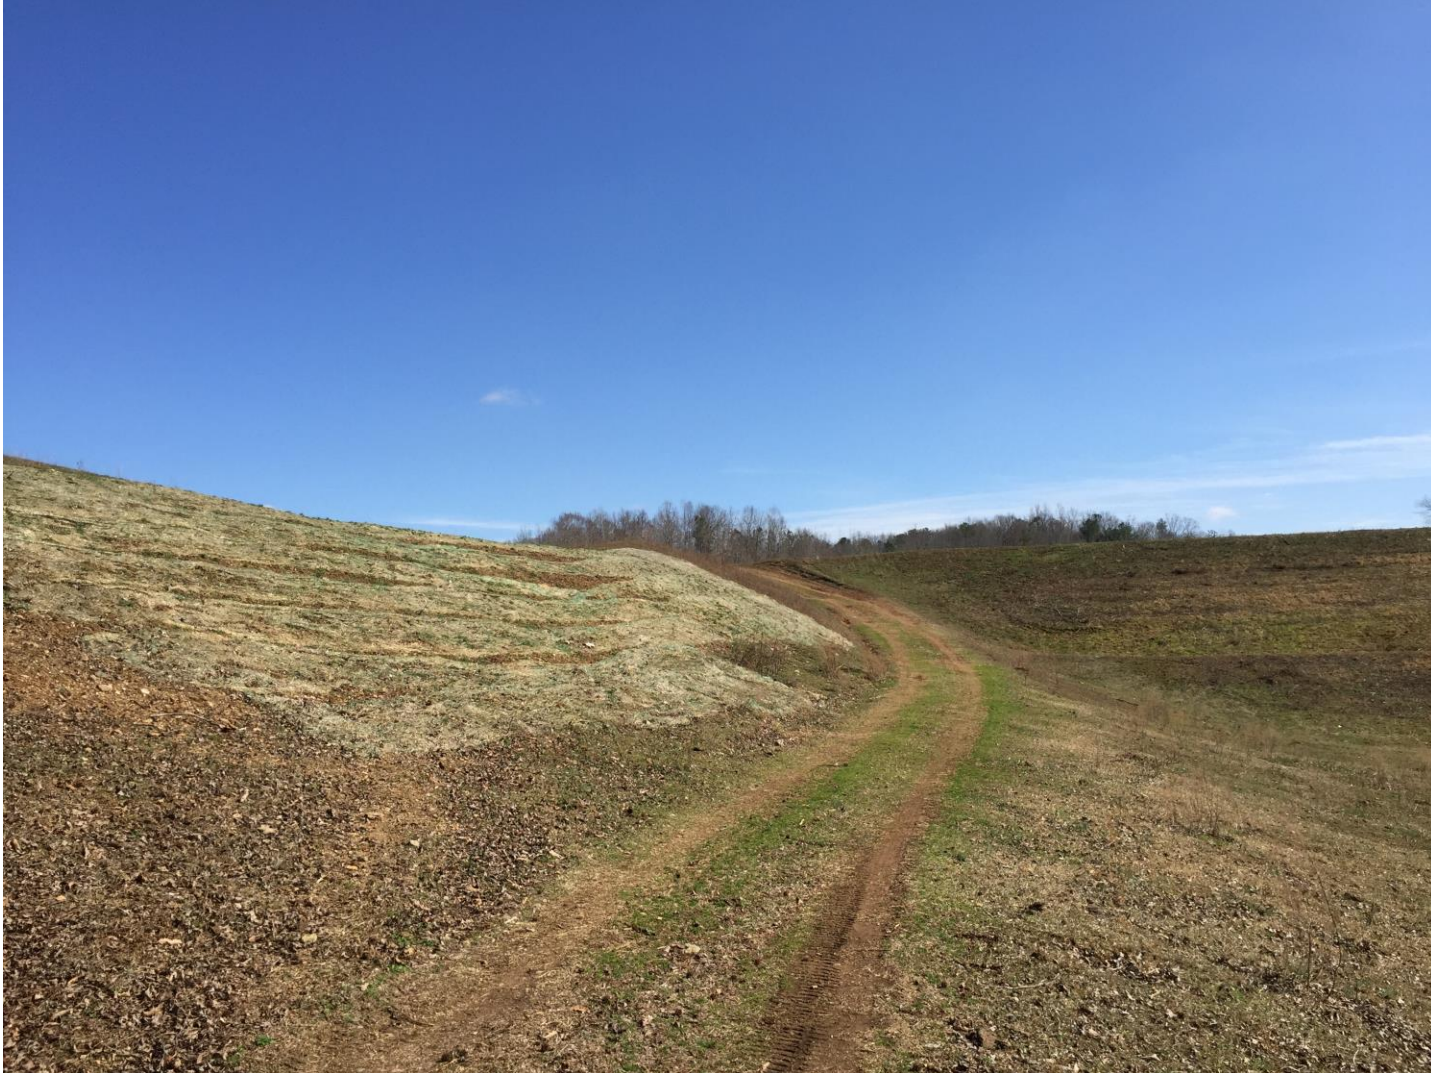
# Auxiliary spillway – repair

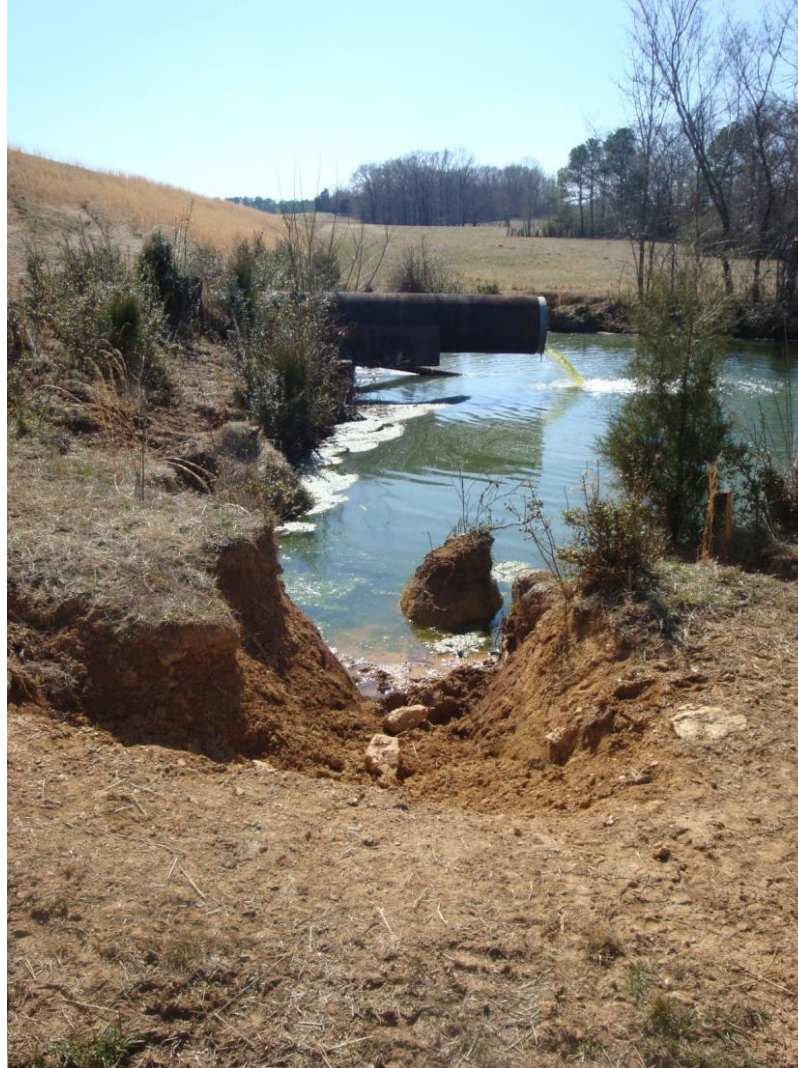
# Livestock damage

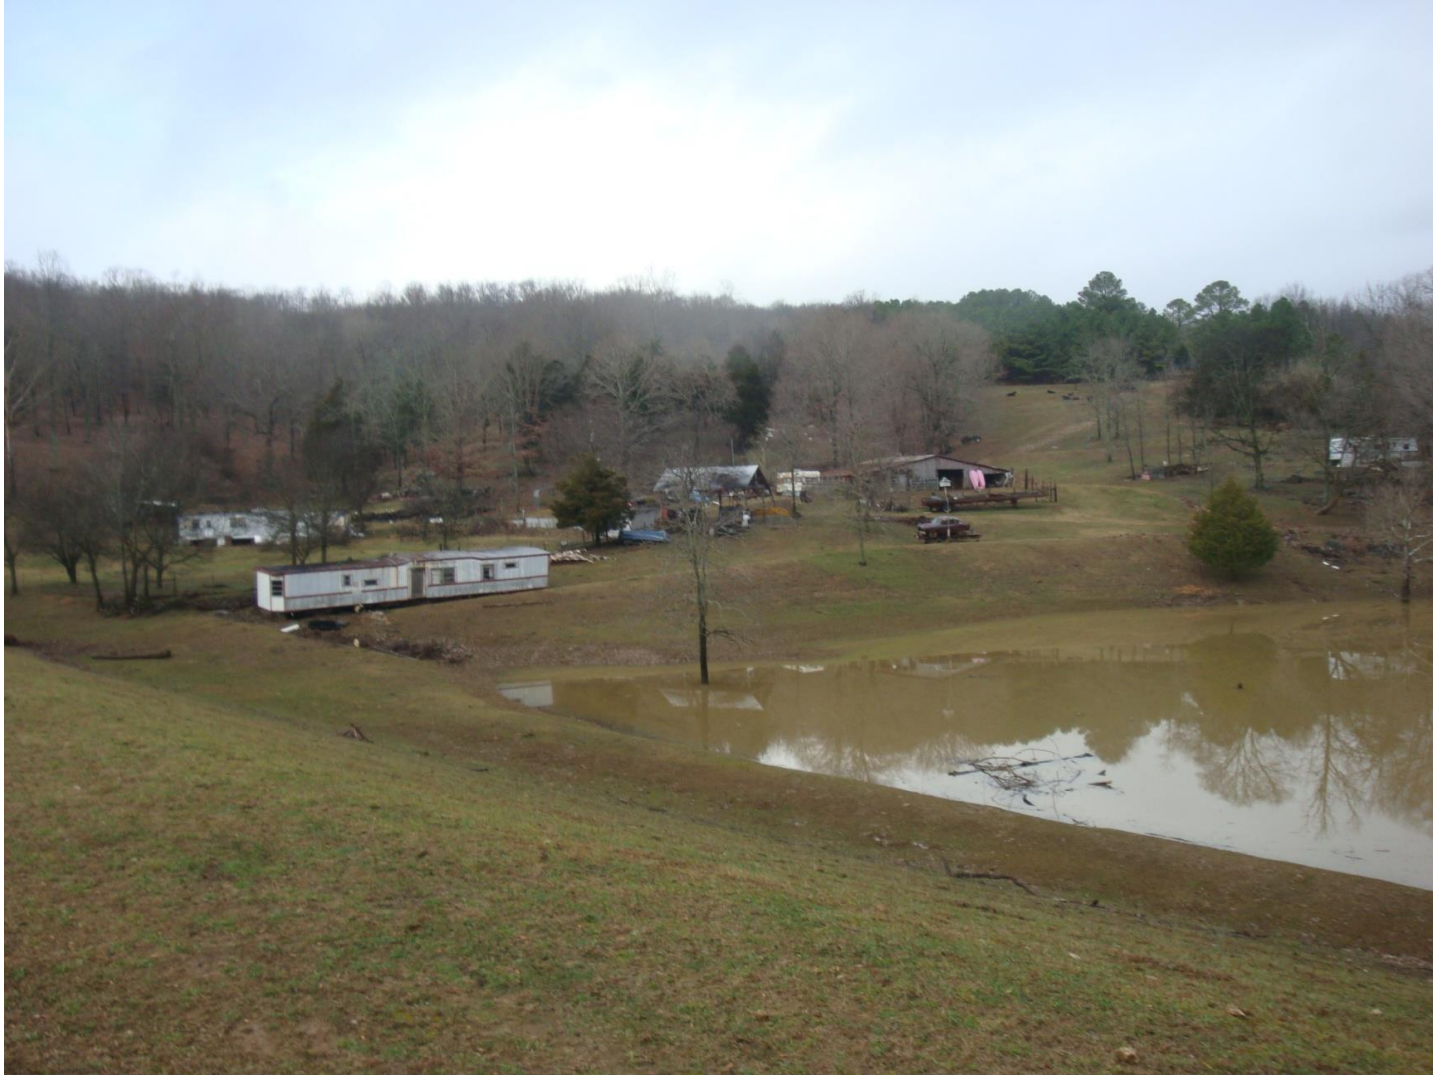
# Structures below the top of the dam

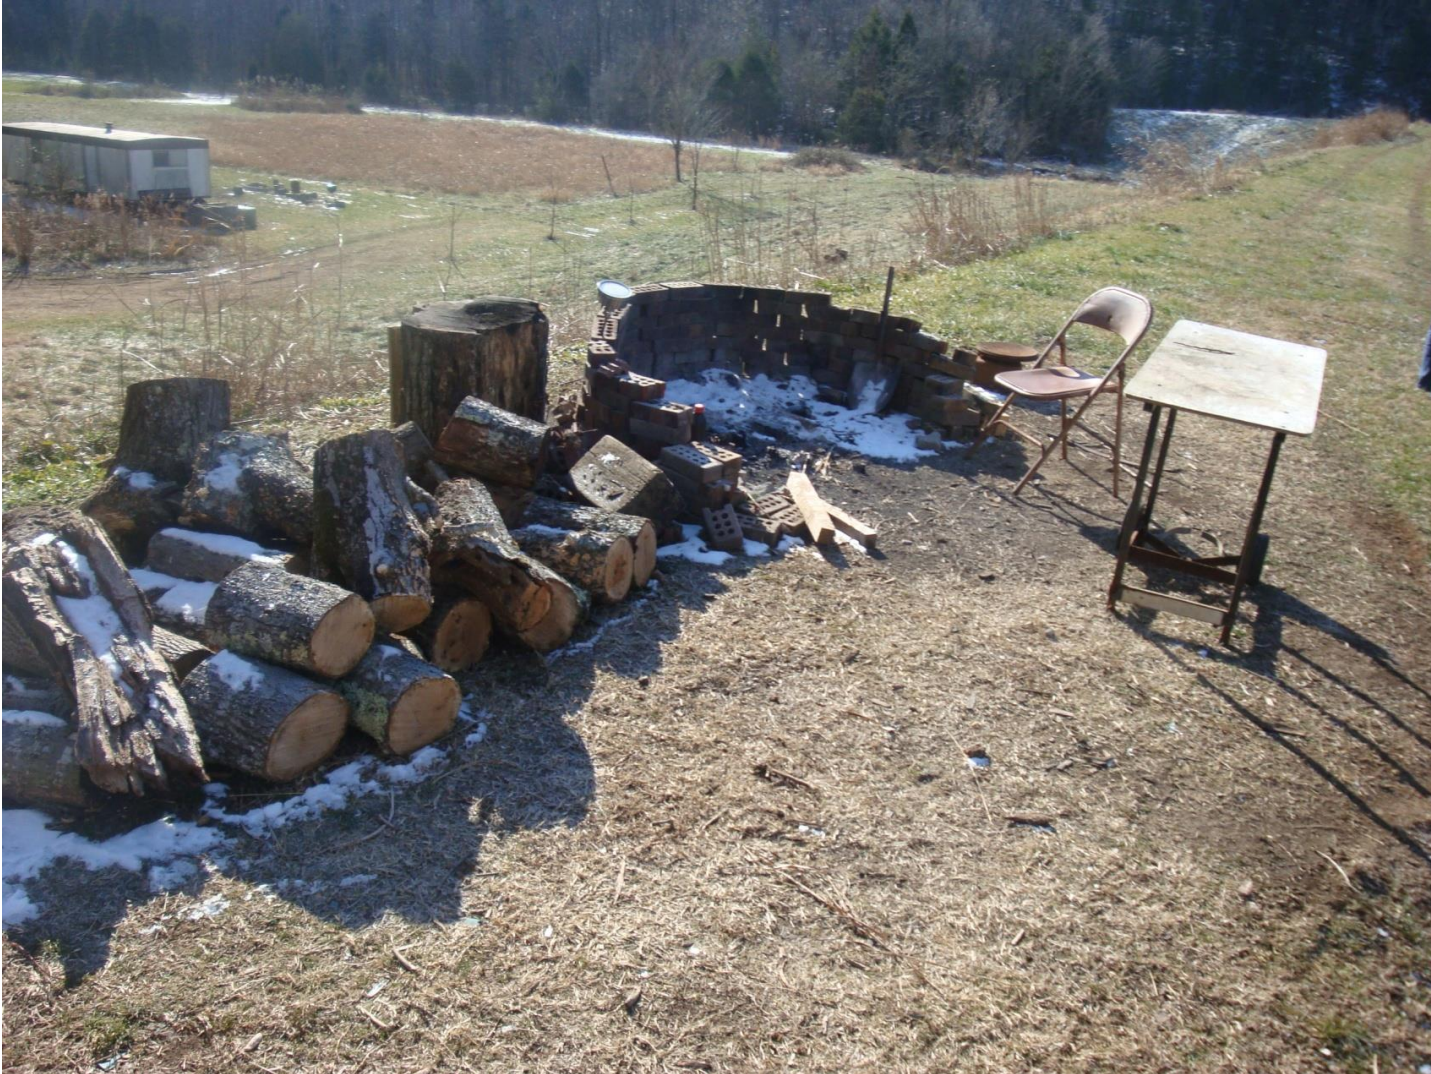
# Downstream hazard

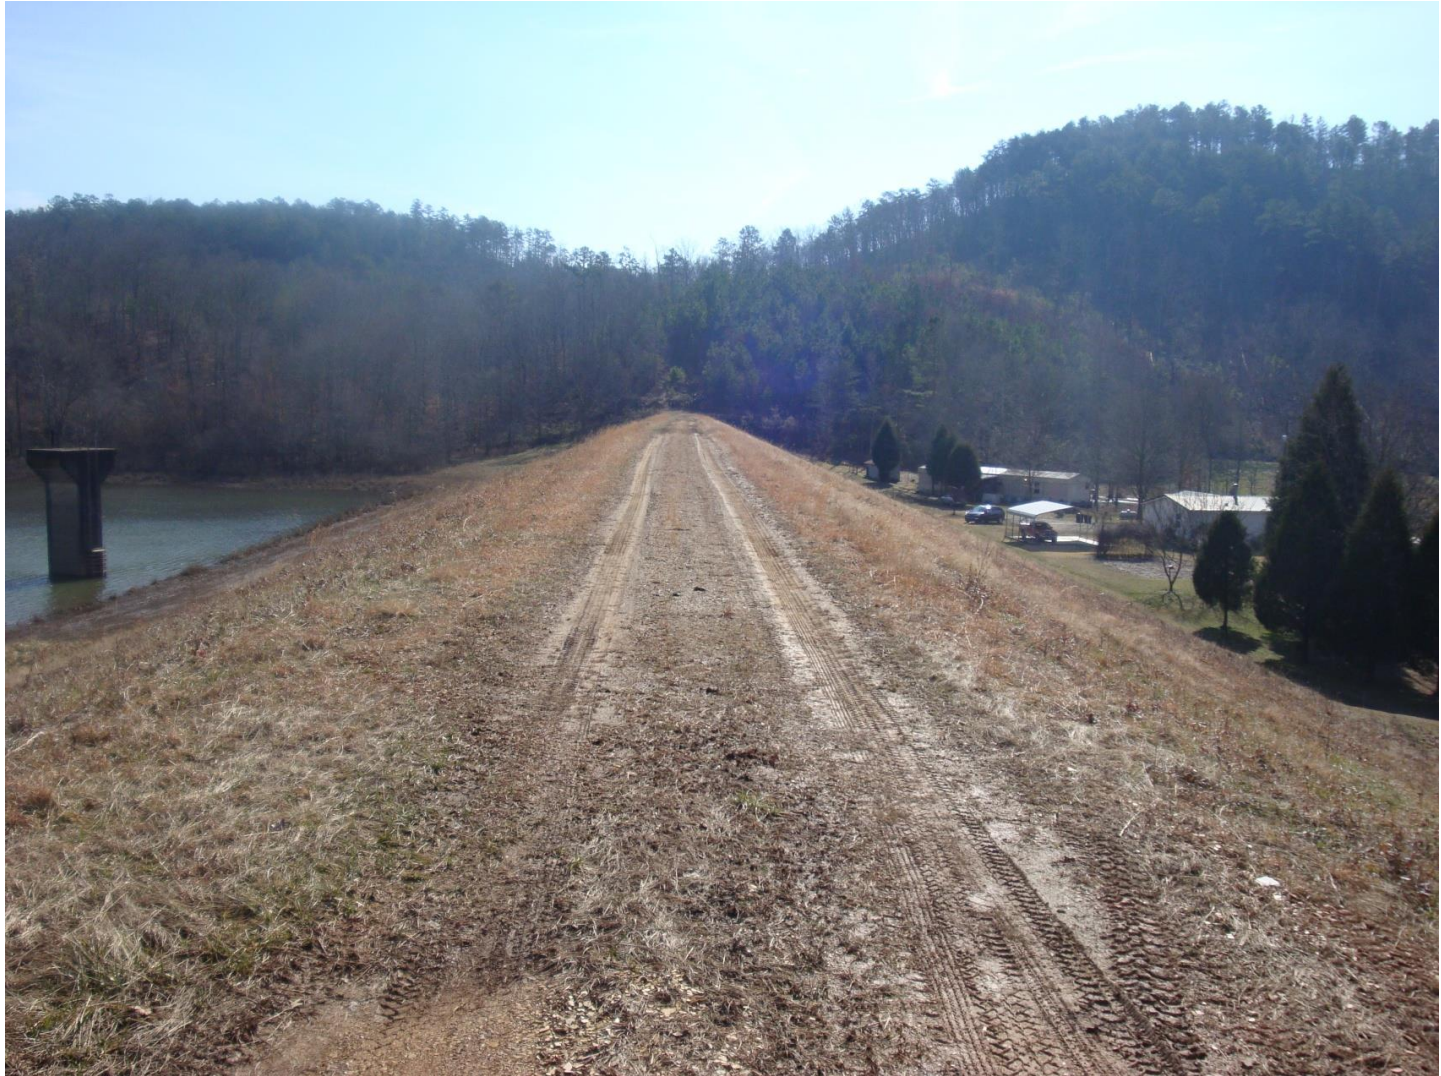
# Downstream hazards
